**OBSERVATIONS OF STRESS CORROSION CRACKING  
BEHAVIOUR IN SUPER DUPLEX STAINLESS STEEL**

A thesis submitted to The University of Manchester for the degree of  
Doctor of Philosophy in the Faculty of engineering and physical science

**2011**

**Mohammed Al-Rabie**

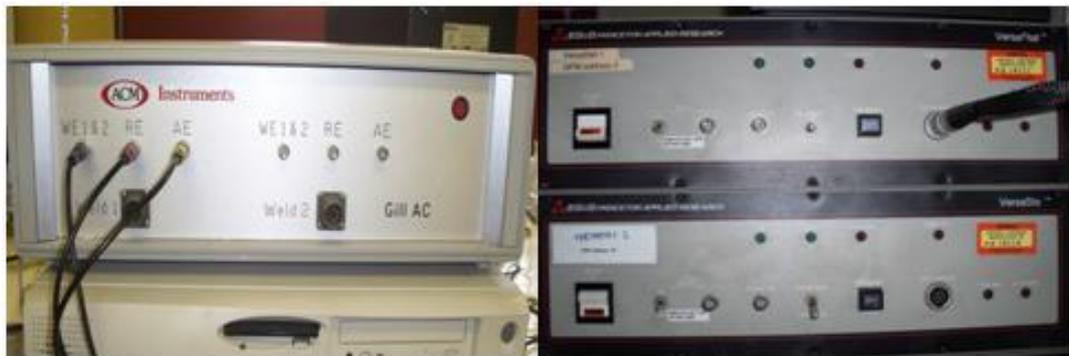
The electrochemical measurements were performed to study the pitting susceptibility of Zeron 100 SDSS. These tests were carried out by using either a Gill AC three electrode potentiostat from ACM Instruments or an EG&G potentiostat, depending on availability (Figure 3-2).

**Figure 3-2: Potentiostats from ACM Instruments and EG&G.**

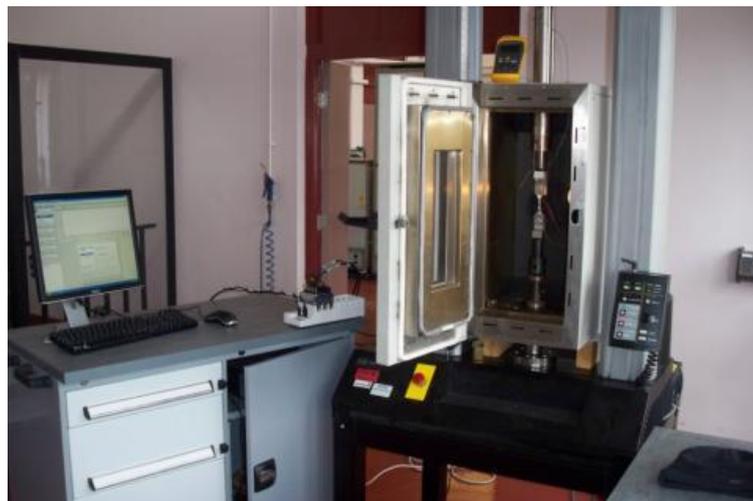
The mechanical tensile tests were carried out on flat tensile samples before and after the strain hardening via cold-rolling. The tensile testing was performed at 80°C on an INSTRON 5569 mechanical testing machine at a cross-head speed of 1 mm / minute. An extensometer of 8mm gauge length attached to the specimens to calculate the elongation during the test.

**Figure 3-8: Mechanical tensile testing machine INSTRON 5569.**

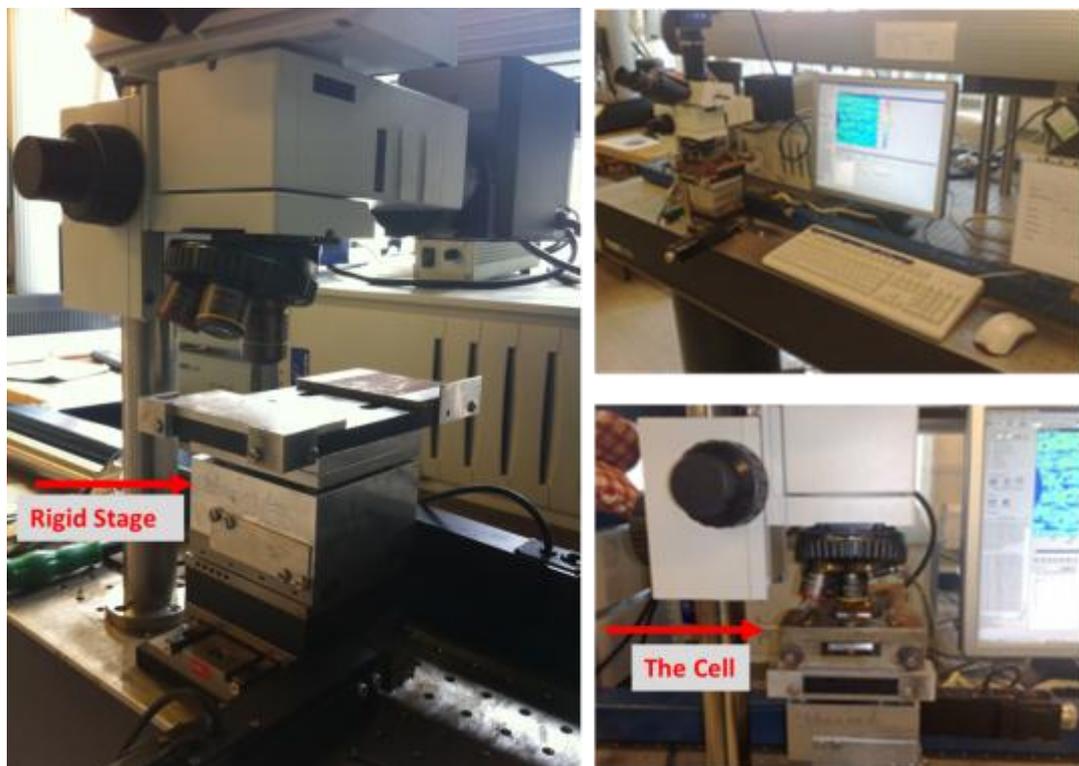
**Figure: 3-9: Setup of the rig under the DIC optical microscope.**

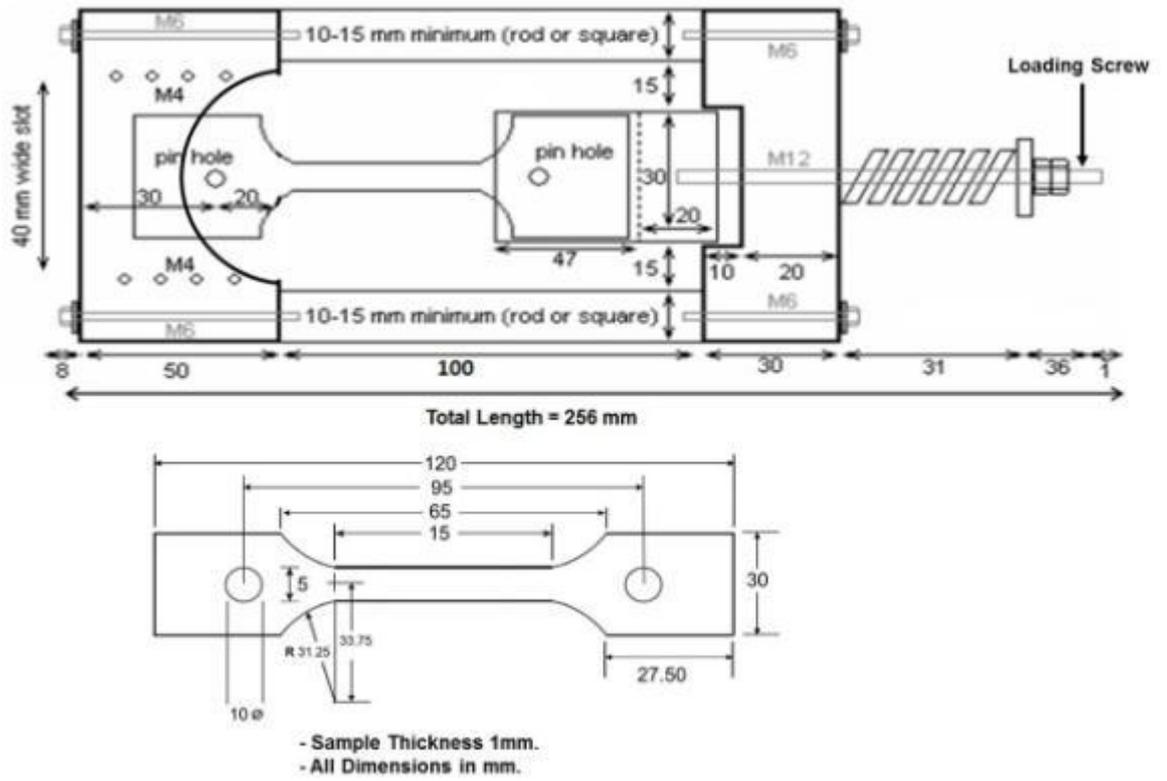
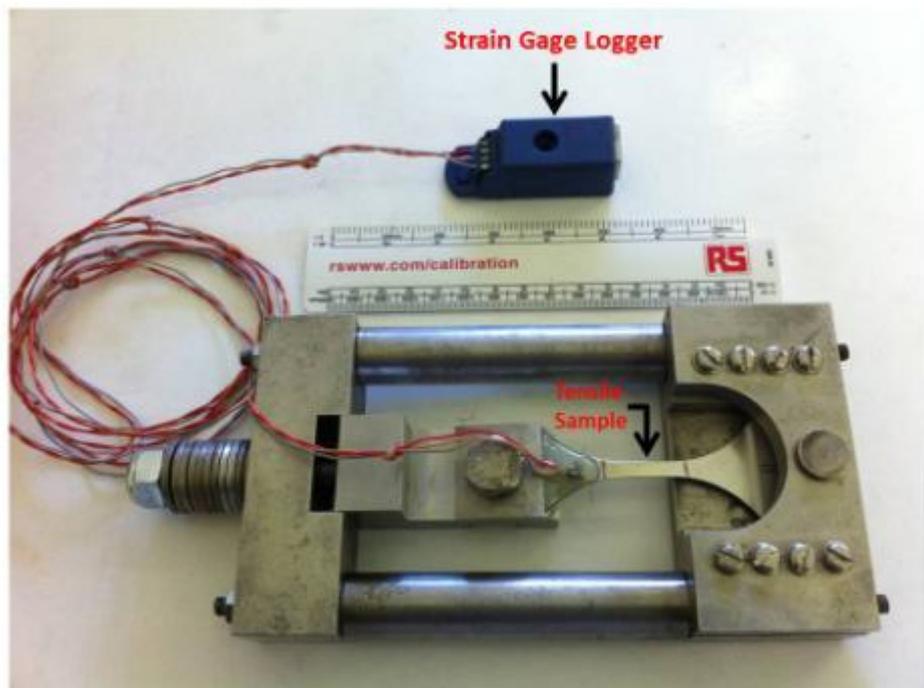
Figure 3-10: The constant load cell and the dimensions of the sample.

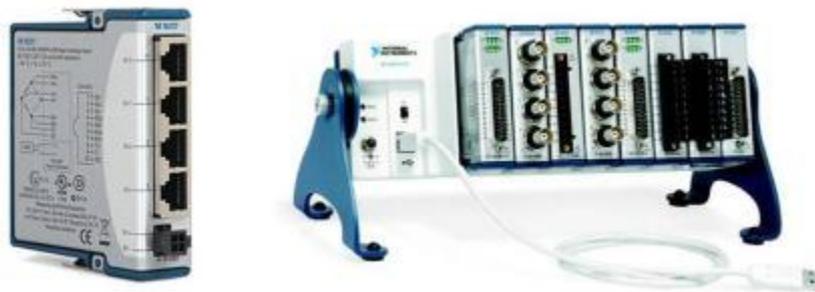
**Figure 3-12:** NI 9237 C Series and NI CompactDAQ 8-Slot Data Logger.

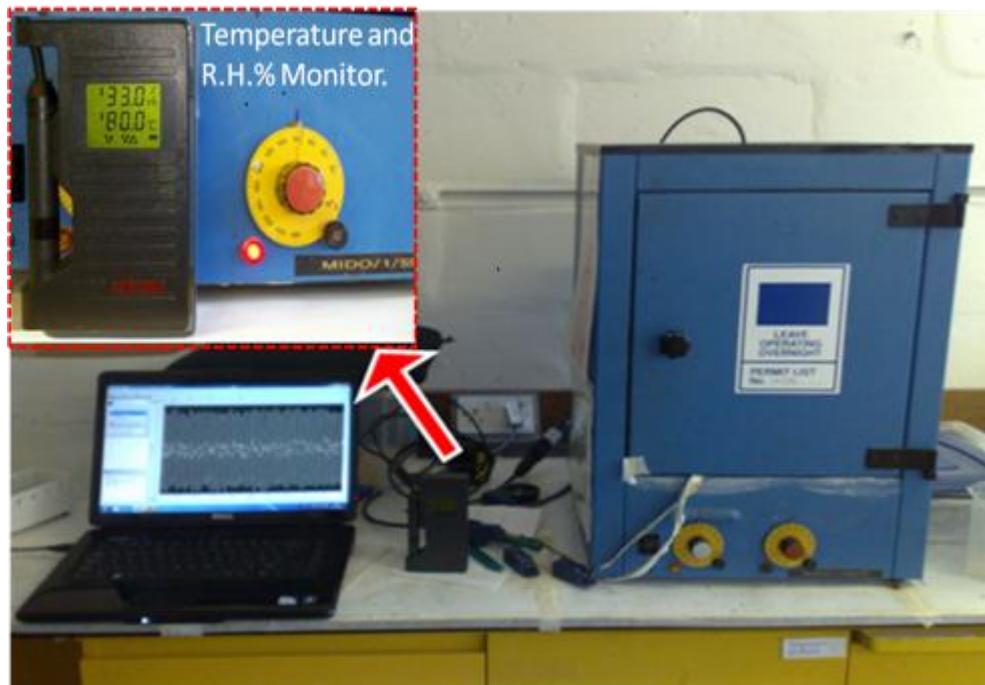
Figure 3-14: Image shows the main setup of the experiment.

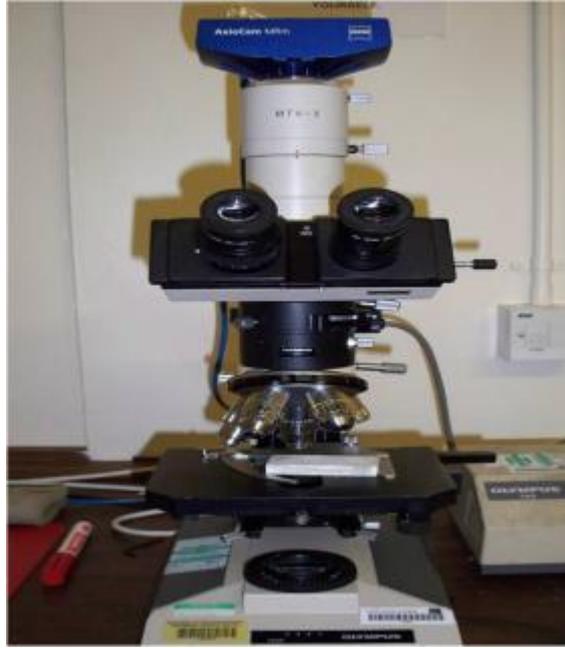
The light optical microscope used was the Olympus-BH2 which is interfaced with Axio Cam MRm ZEISS and equipped with an Olympus MSPlane lens (Figure3-15).

**Figure 3-15: Optical Microscope (OM), Olympus-BH2.**

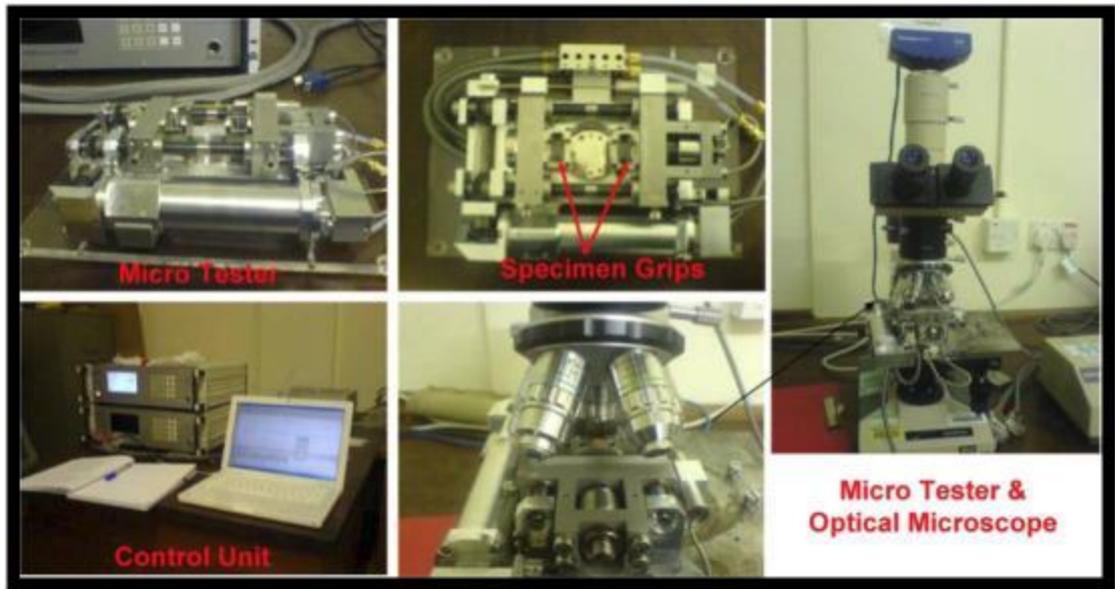
Figure 3-18: Micro-tensile-testing device tester with control units, and optical microscopy, interfaced to the ZEISS MRm AxioCam digital camera.

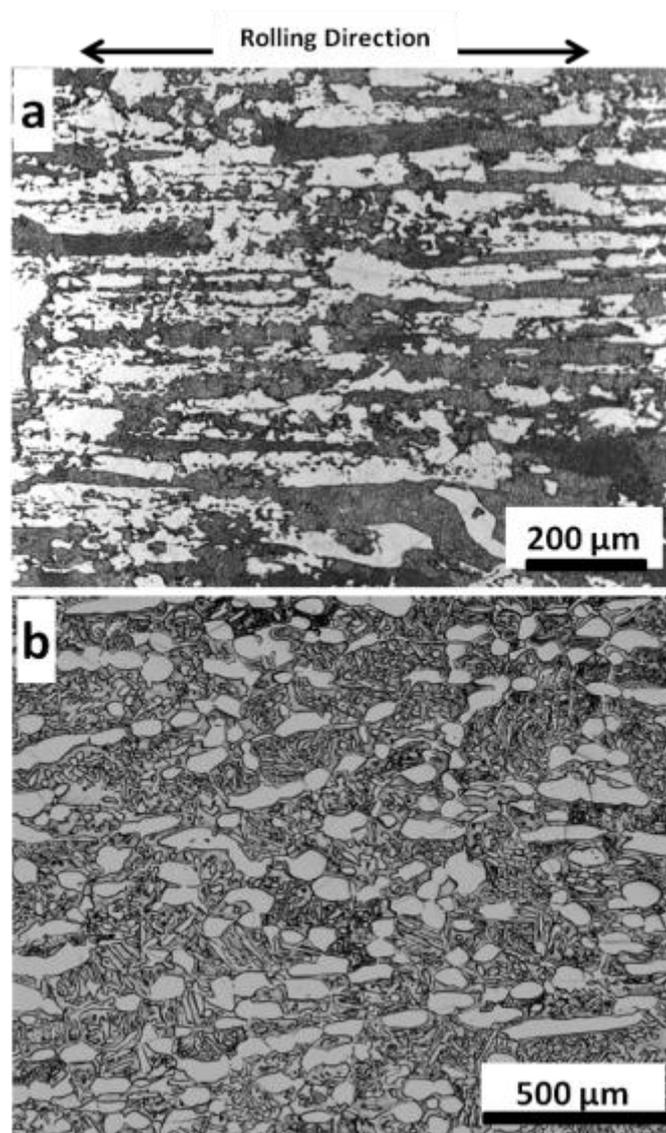
**Figure 4-1: Optical micrographs of (a) the 3-mm plate SDSS as-received and (b) forged SDSS sheet as received microstructures (ferrite is dark and austenite is light).**

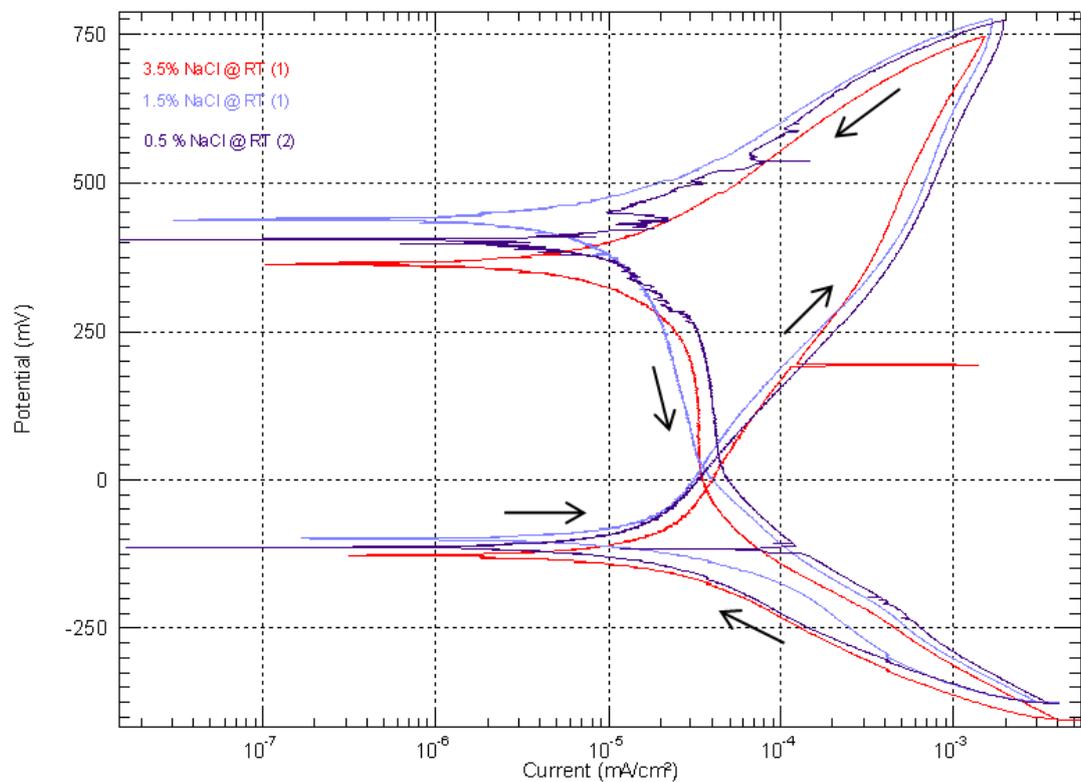
**Figure 4-2: Cyclic polarisation of sample in 0.5%, 1.5% and 3.5% NaCl solution at room temperature.**

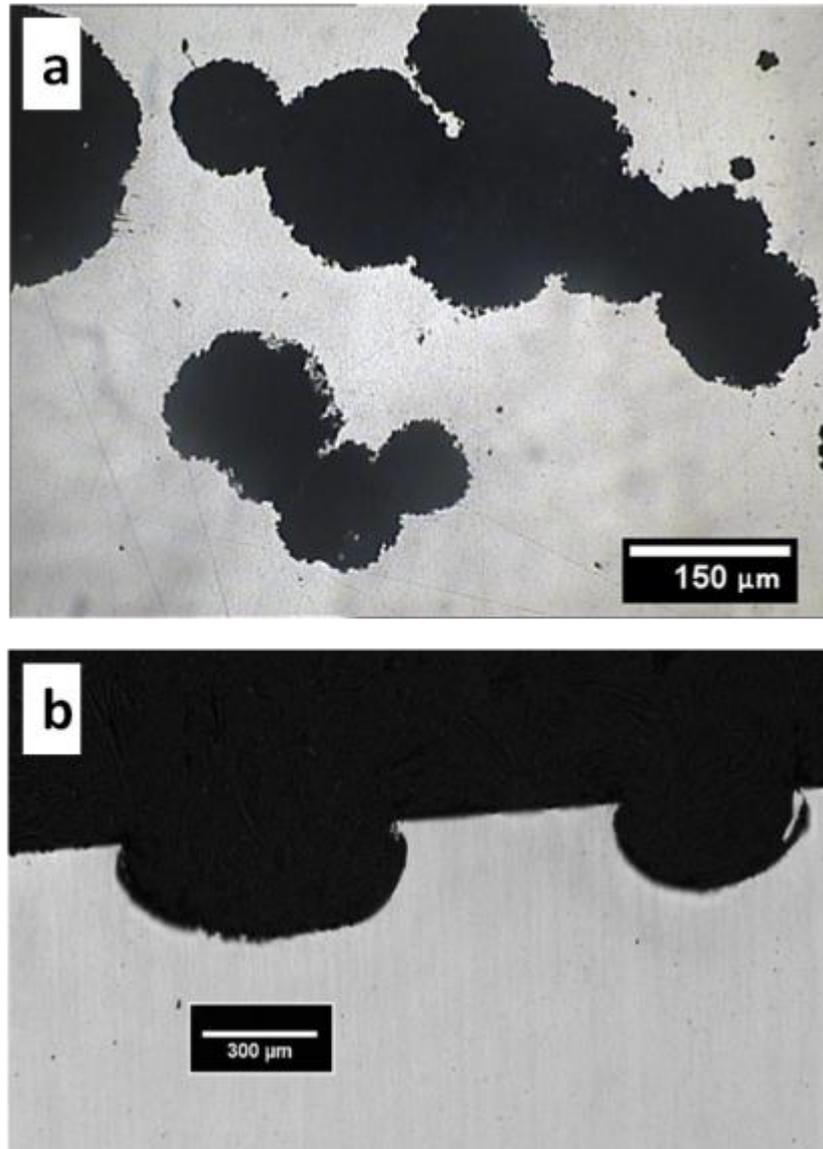
**Figure 4-5: Optical micrographs for a) the pits with lacy appearance and b) for cross section of sample all created in the sample after polarisation testing in 5M NaCl at 70°C.**

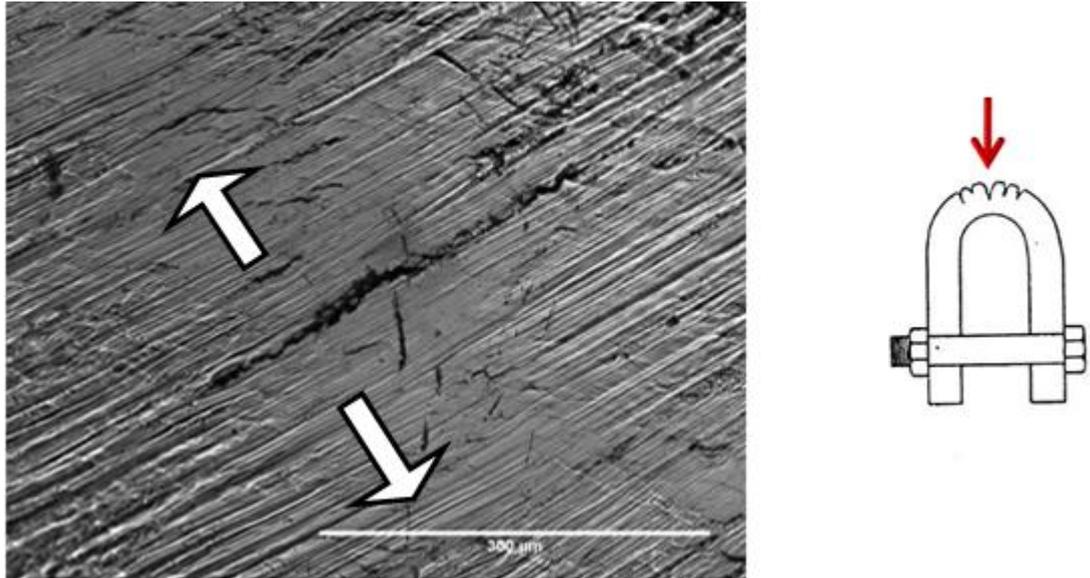
Figure 4-8: Optical micrograph for the top surface of the U-bend sample after testing under droplets of 0.52M  $MgCl_2$  at 80°C and 42% RH. The white arrows on Figure indicate to the tensile direction.

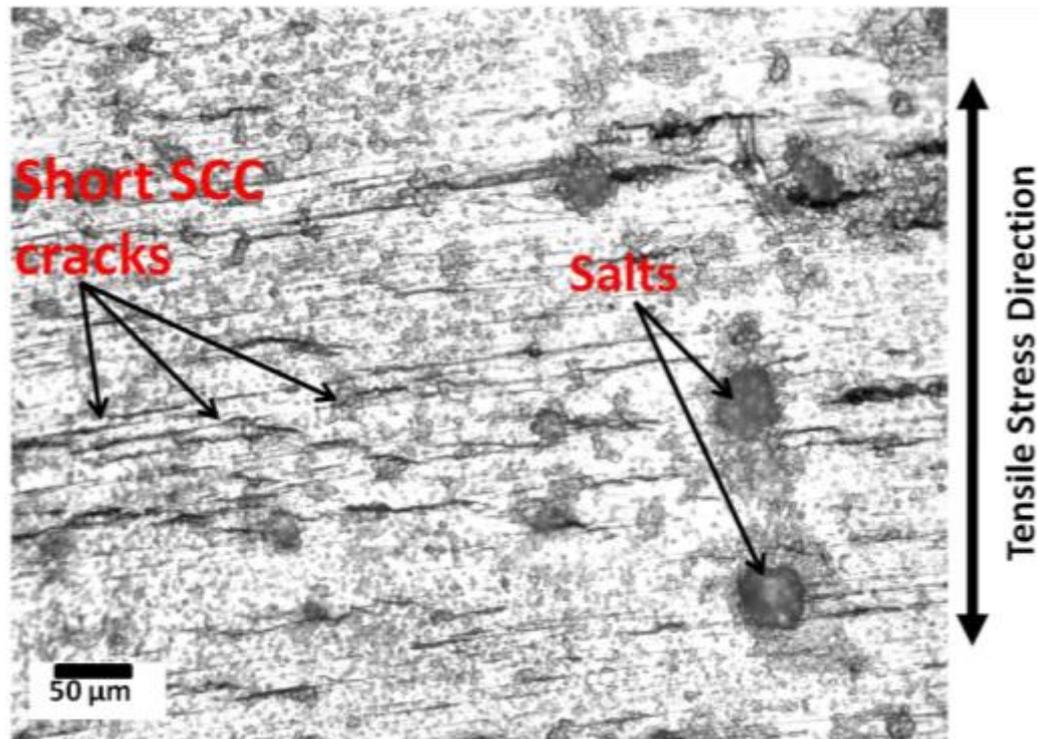
Figure 4-9: Optical micrograph for the top surface of the U-bend sample after the test shows the initiation of the stress corrosion cracking normal to the loading direction

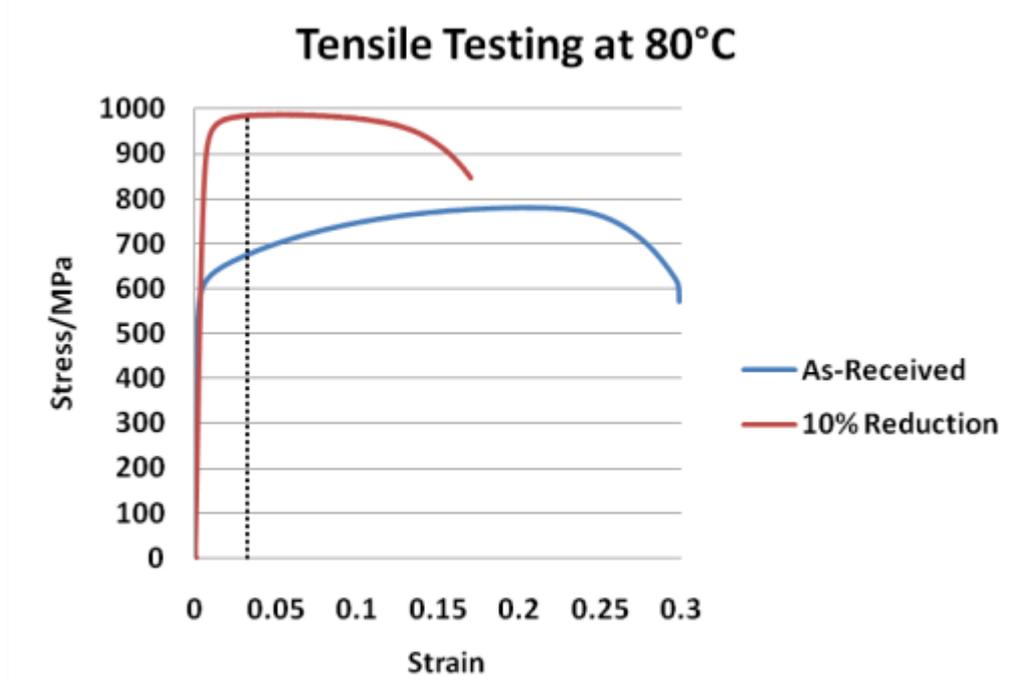
**Figure 4-11: Stress/Strain behaviours of the rolled and solution annealed sample tested at 80° C, dashed line indicated to the selected strain (3%) and the considered stresses ( $1.05\sigma_y$ ) for both samples.**

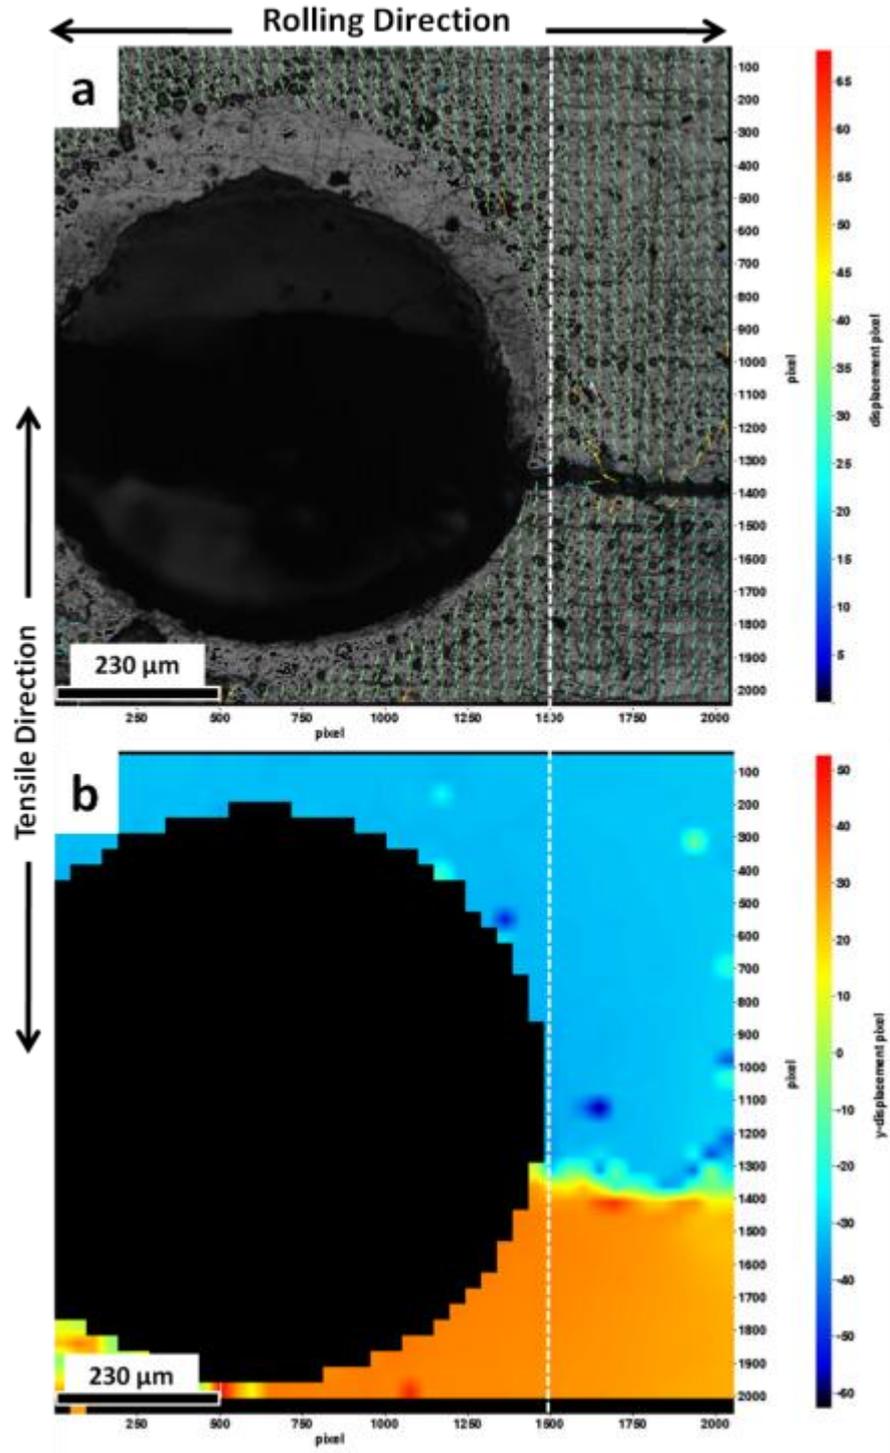
Figure 4-25: The first observed (a) vectors and (b) displacement maps after the crack initiated after (942 Hours-wet droplet)-right branch. Dashed line show the x-position for SCOD measurements.

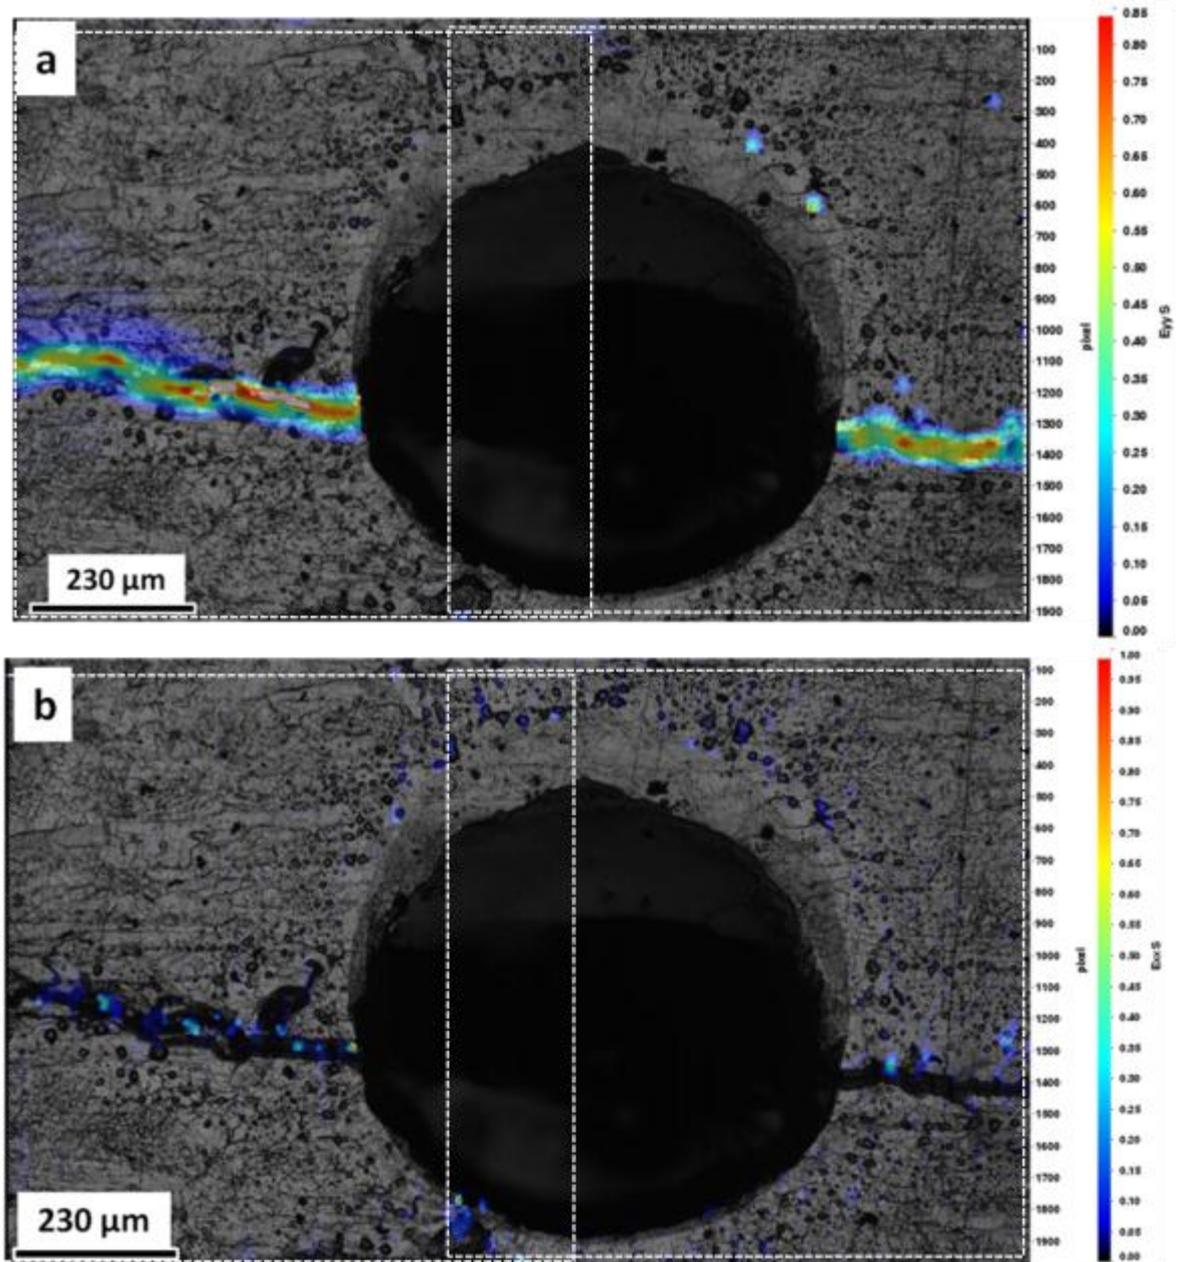
**Figure 4-26: Strain maps of the propagated crack after 942 hours showing a) the  $E_{yy}$  strain (perpendicular to the crack) and b)  $E_{xx}$  strain (parallel to the crack). Dashed rectangles show the actual locations of two sets of images used to obtain the overlapped strain maps.**

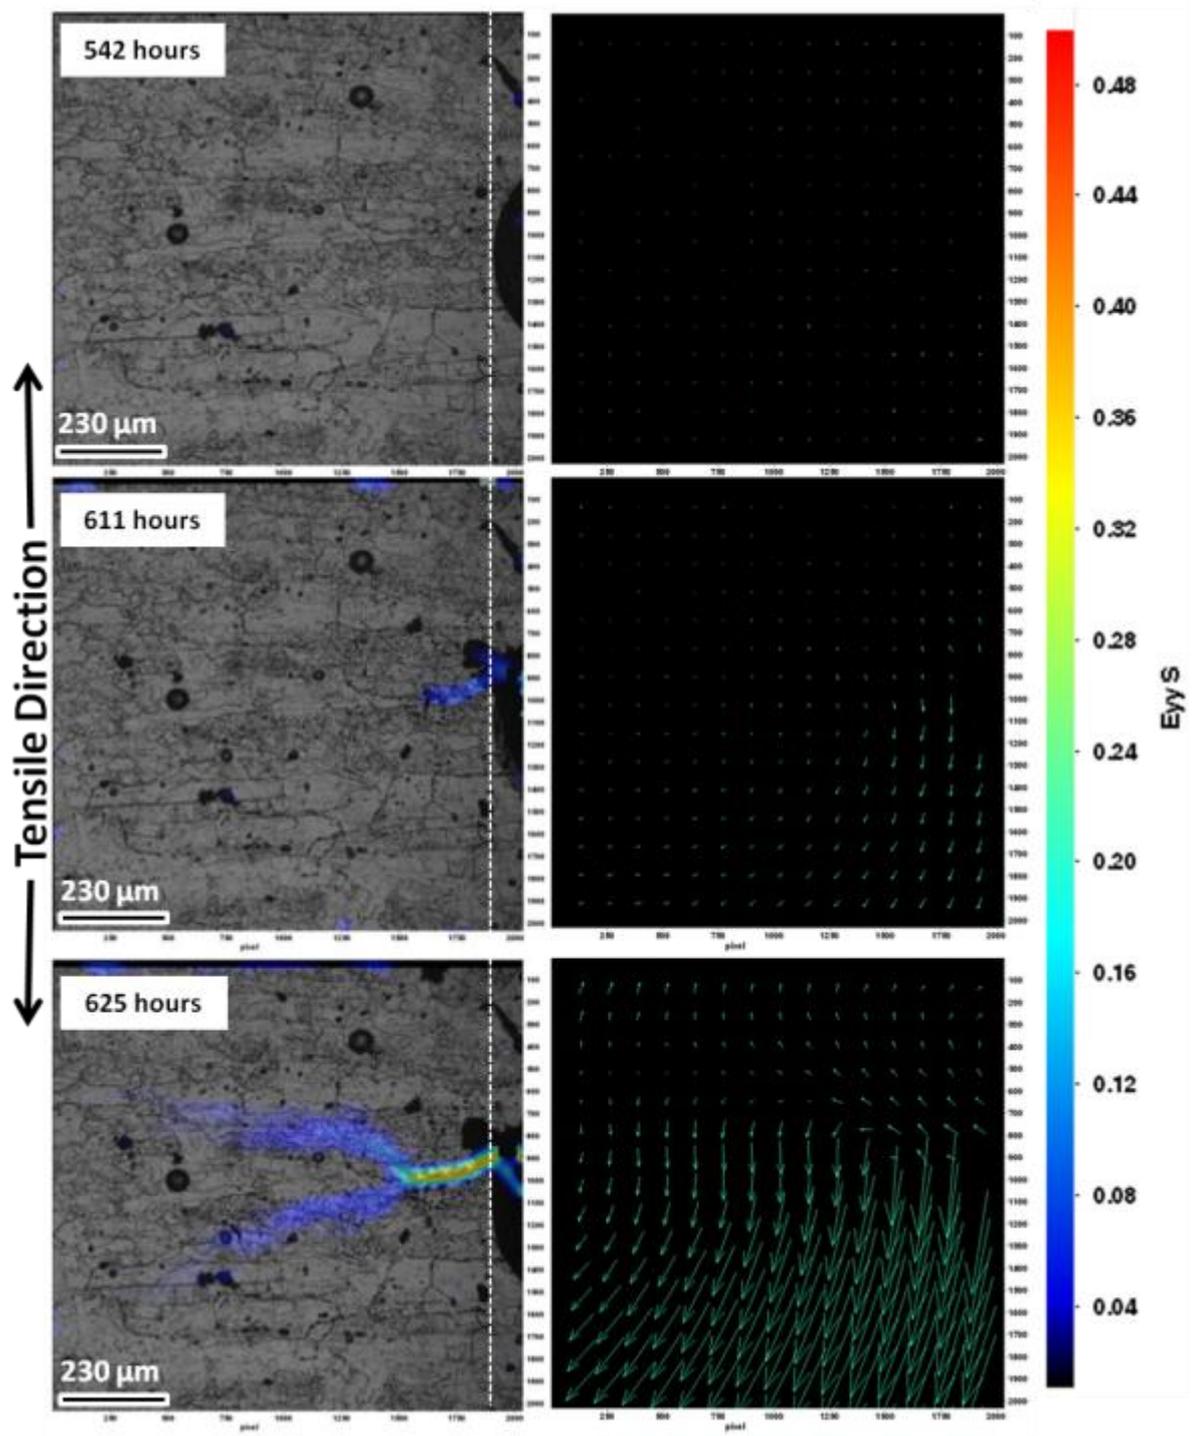
Figure 4-31: A series micrographs with strain maps superimposed and vertical displacements maps to show crack opening displacements relative to the first image (T-T sample, crack propagation perpendicular to the loading direction).

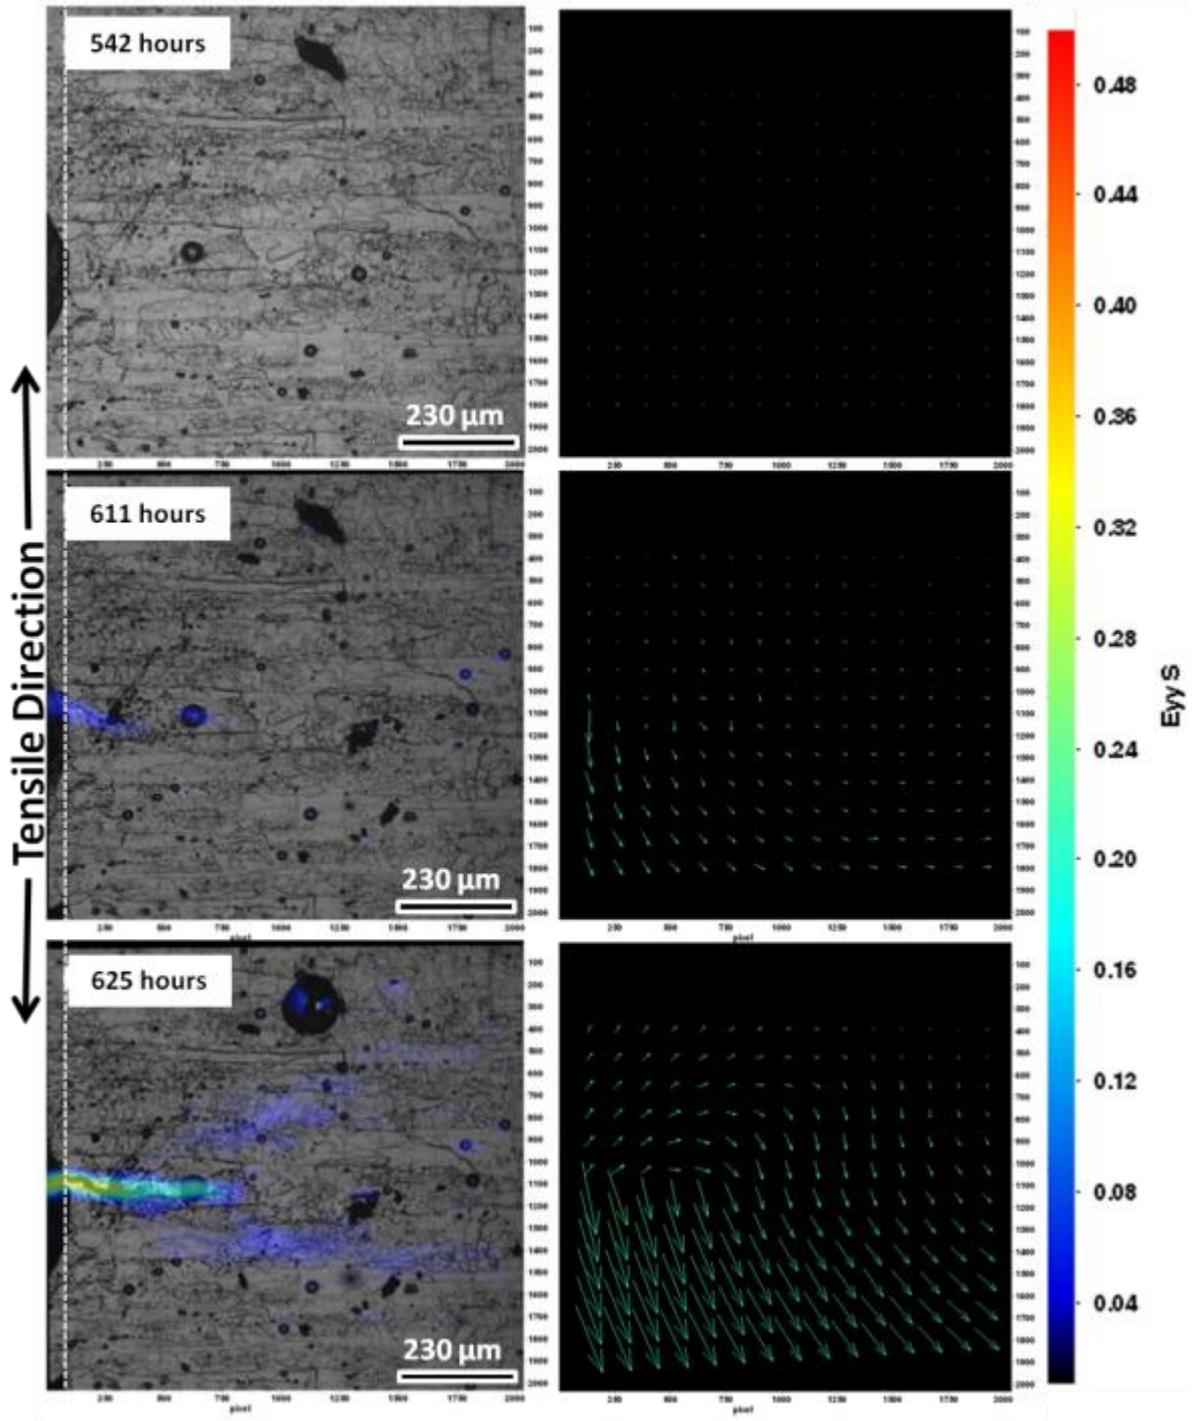
Figure 4-32: A series micrographs with strain maps superimposed and vertical displacements maps to show crack opening displacements relative to the first image (T-T sample, crack propagation perpendicular to the loading direction).

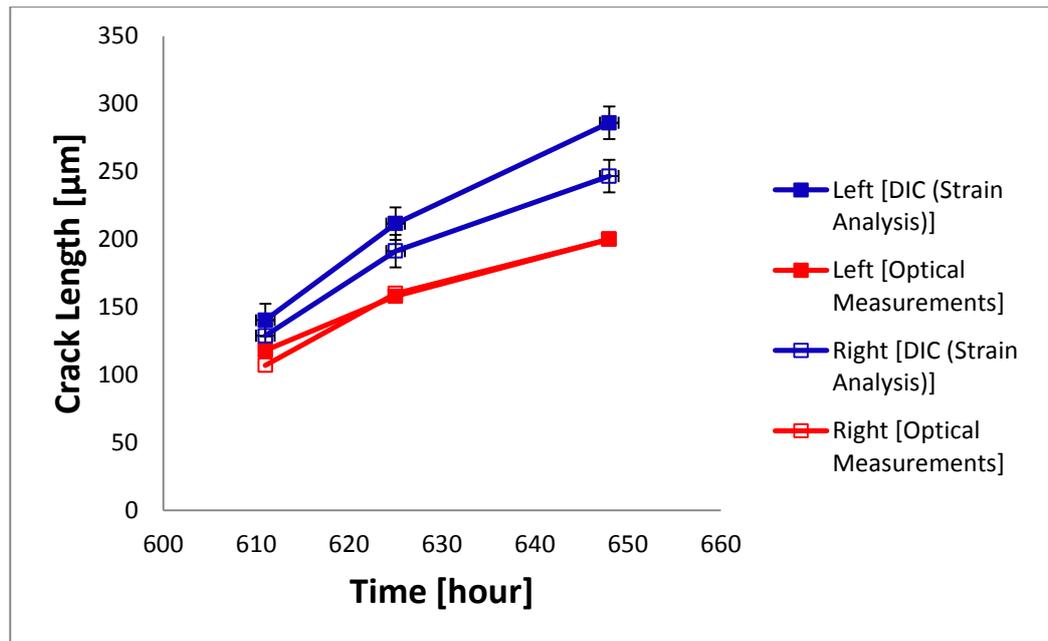
**Figure 4-37: Evaluation of crack length as measured by optical measurements and DIC (strain analysis) for left and right cracks shown in Figures 4-31 and 4-32.**

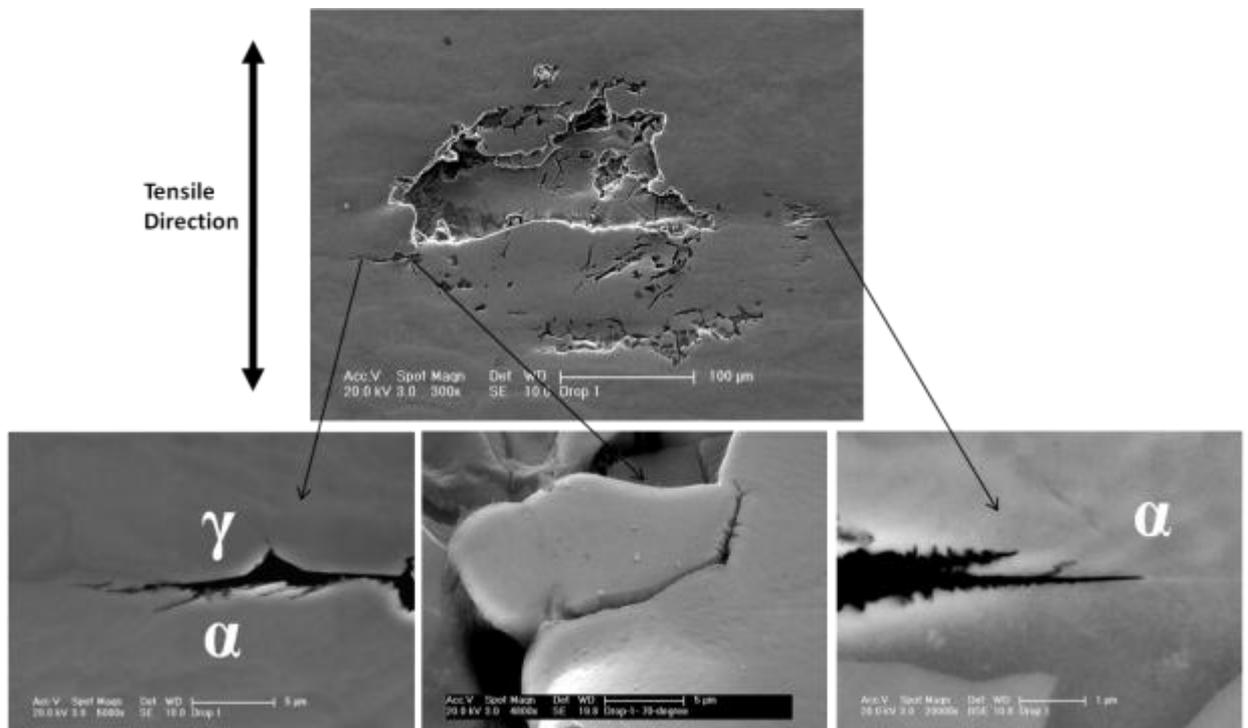
Figure 4-47: Selective dissolution and pitting resulted in initiation of short cracks perpendicular to the load direction under the salt droplets.

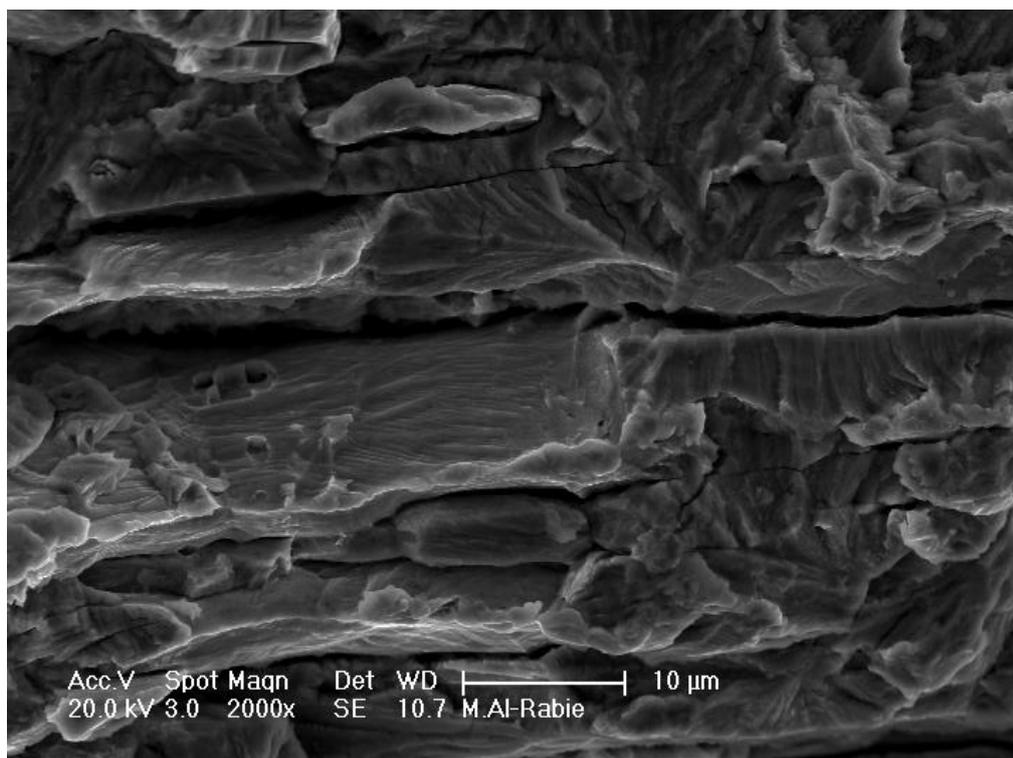
**Figure 4-58: The fracture surface shows a typical stress corrosion cracking fracture.**

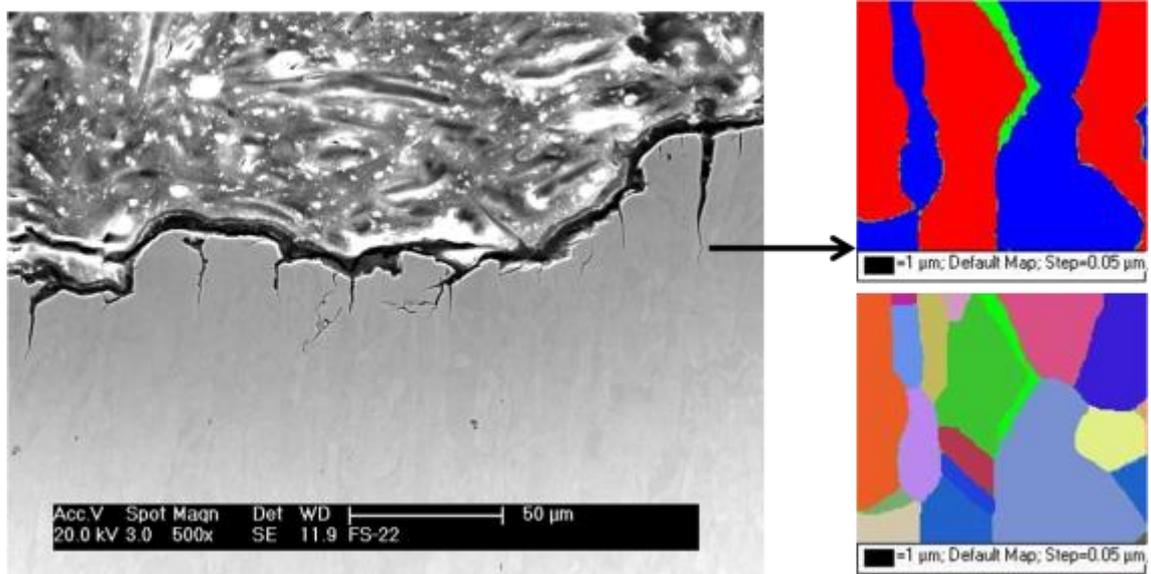
**Figure 4-63: SEM image shows the secondary cracks in the cross section of the fracture surface propagated vertical to the main cracking direction along  $\alpha/\gamma$  interphase.**

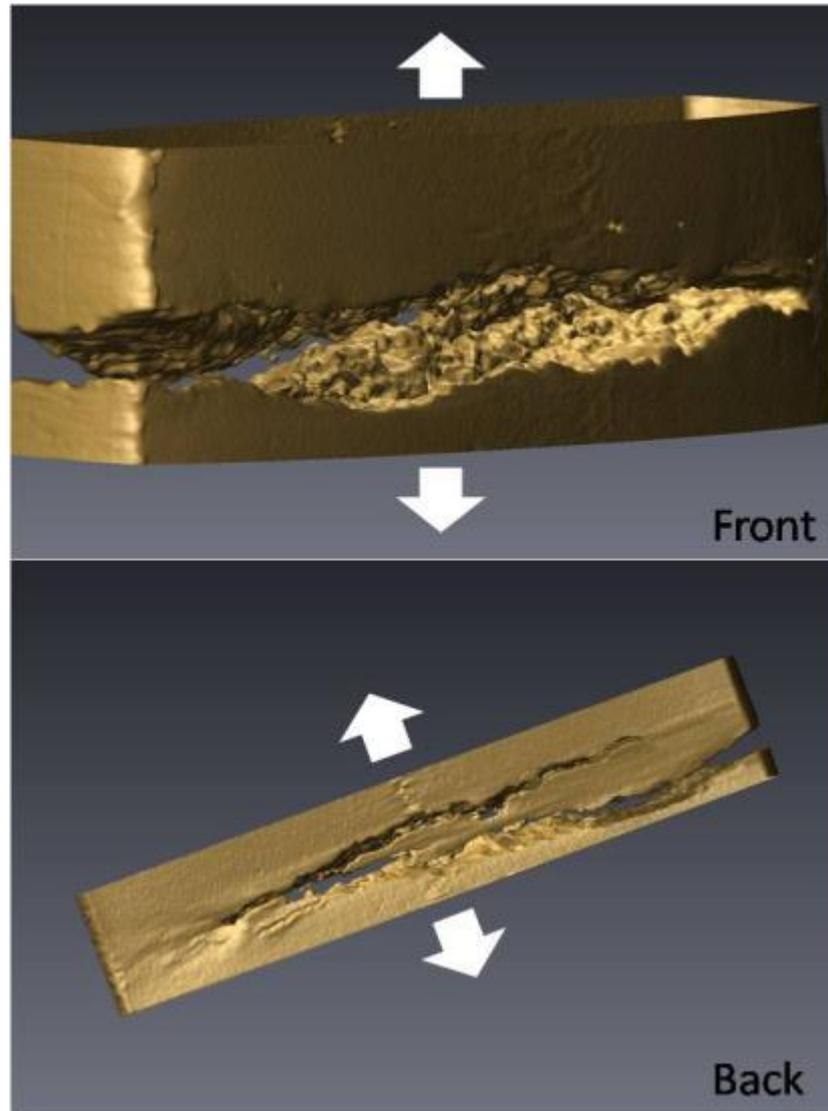
**Figure 4-64: Reconstructed 3-D tomography images for the crack created in the rolled sample, the arrows show the loading direction.**

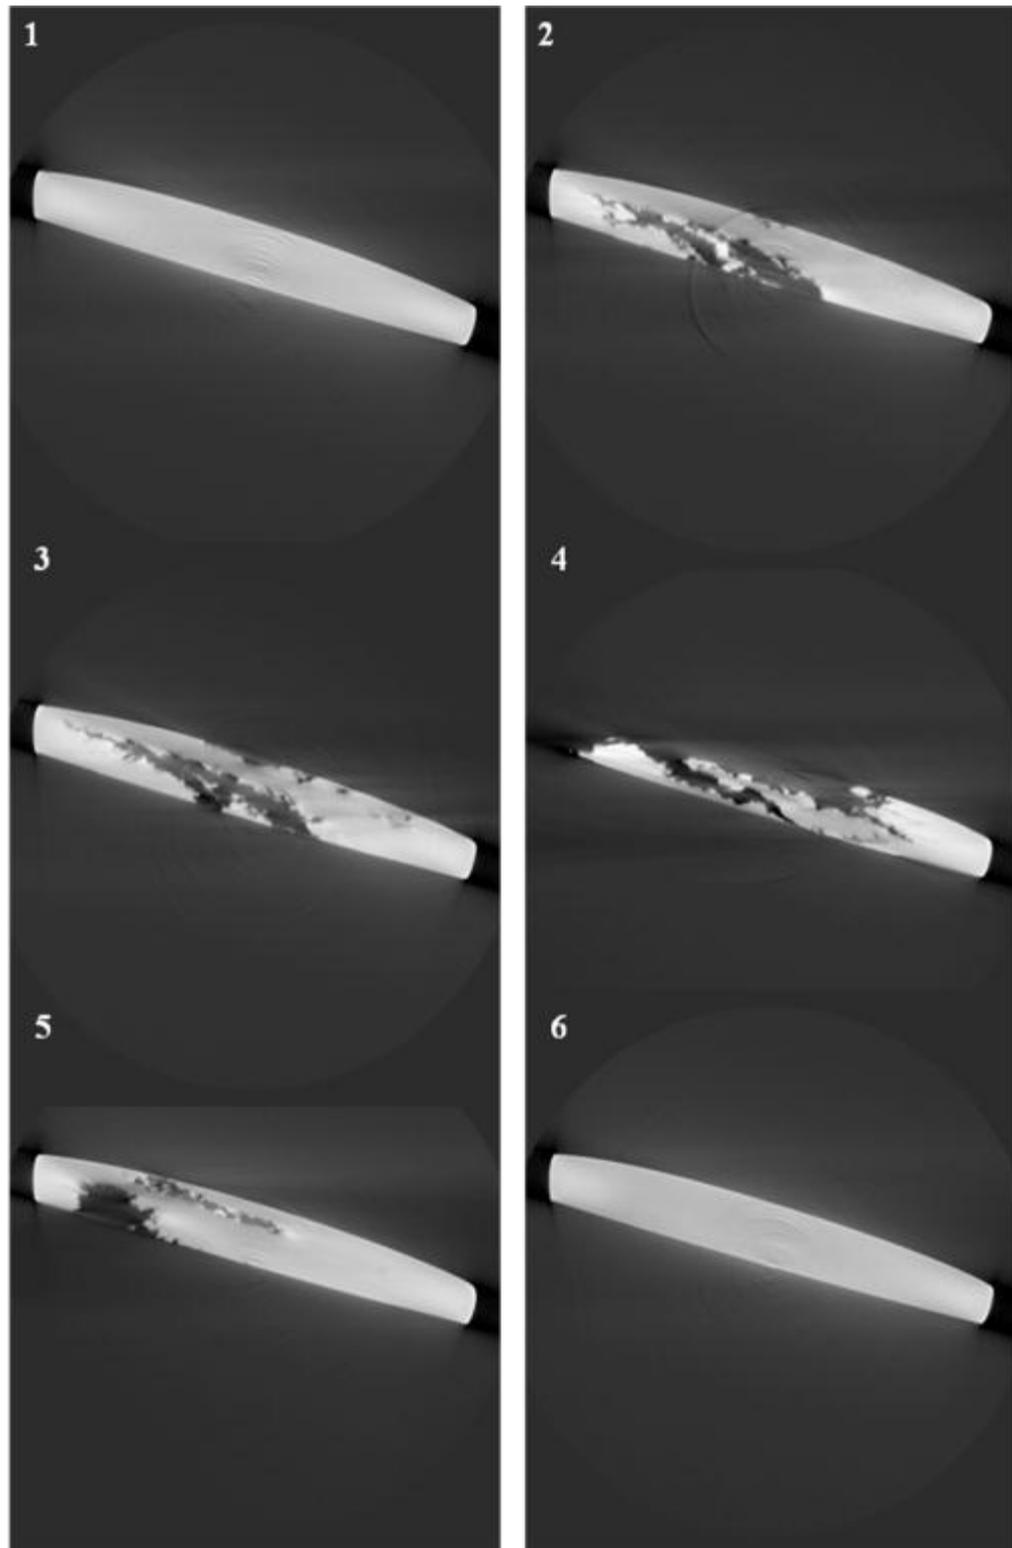
**Figure 4-65: 2D Tomography sections through the data collected from the crack in the rolled sample.**
