**OBSERVATIONS OF STRESS CORROSION CRACKING  
BEHAVIOUR IN SUPER DUPLEX STAINLESS STEEL**

A thesis submitted to The University of Manchester for the degree of  
Doctor of Philosophy in the Faculty of engineering and physical science

**2011**

**Mohammed Al-Rabie**

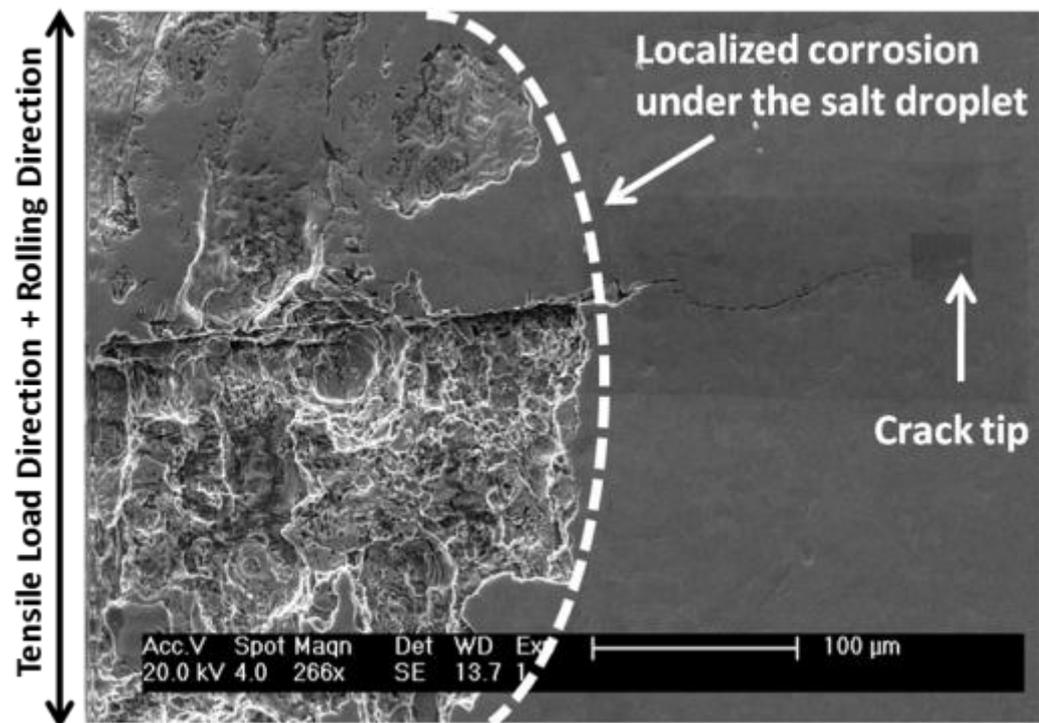
**Figure 4-66: SEM micrograph shows the localized corrosion under the salt droplet and the crack propagated out of the droplet and normal to the loading direction.**

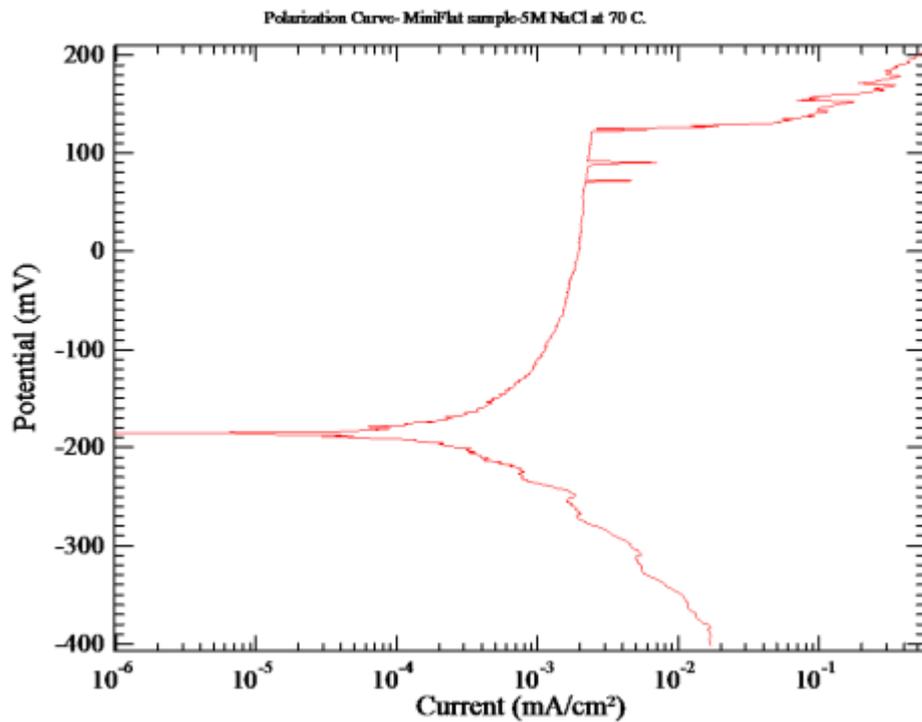
**Figure 4-85: Potentiodynamic polarisation curve of the strained mini flat sample in 5M NaCl at 70°C, potential was measured versus a saturated calomel electrode (SCE)with a scan rate of 10 mV/min.**

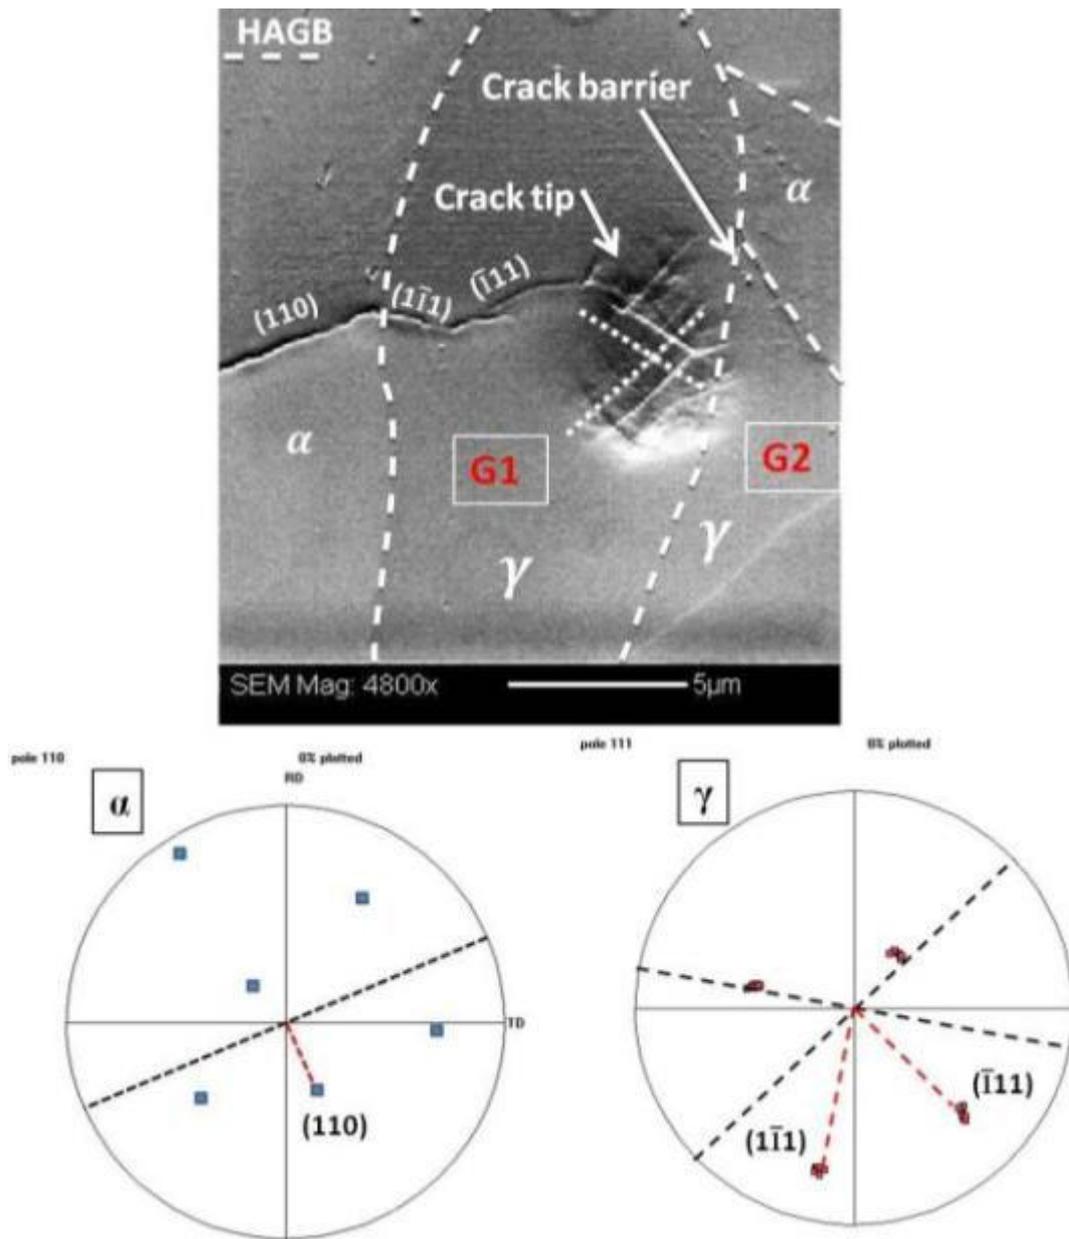
**Figure 5-3: SEM micrograph for the arrested crack with the deformation bands at the crack tip and the traces of the crack on  $\{110\}$  for  $\alpha$ -Phase and on  $\{\bar{1}\bar{1}\bar{1}\}$  for  $\gamma$ -Phase.**

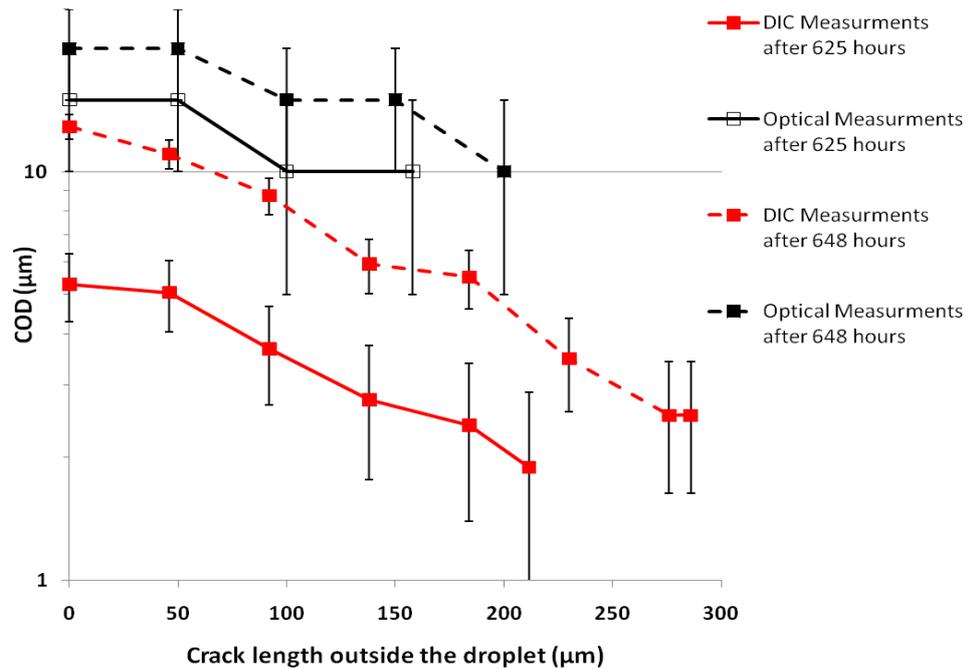
**Figure 5-9: Comparison of cracks measurements done by DIC and optical means showing the potential of the DIC to give better inspection.**
