PERFORMANCE CHARACTERISATION OF DUPLEX STAINLESS STEEL IN NUCLEAR WASTE STORAGE ENVIRONMENT

A thesis submitted to
The University of Manchester for the degree of
Doctor of Philosophy (Ph.D.)
in the Faculty of Engineering and Physical Sciences

2015

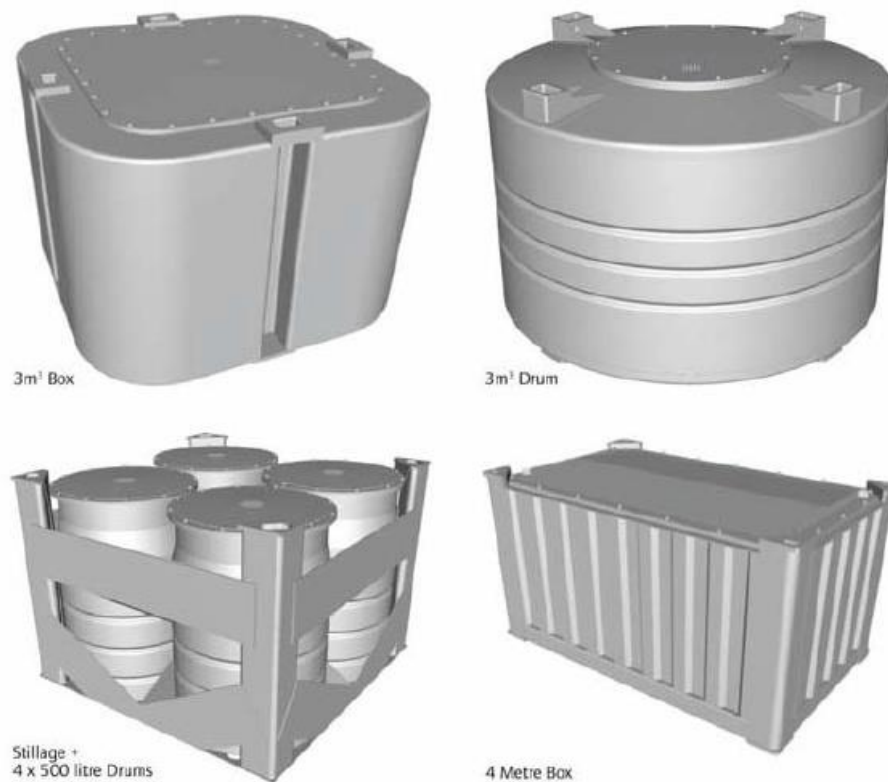
Figure 1-1: Standard waste containers for ILW [6]
