STRENGTHENING MASONRY FOR SEISMIC ACTIONS IN DEVELOPING COUNTRIES

A Thesis Submitted to The University of Manchester in the Faculty of
Science and Engineering for the Degree of Doctor of Philosophy in Civil
Engineering

Ather Ali

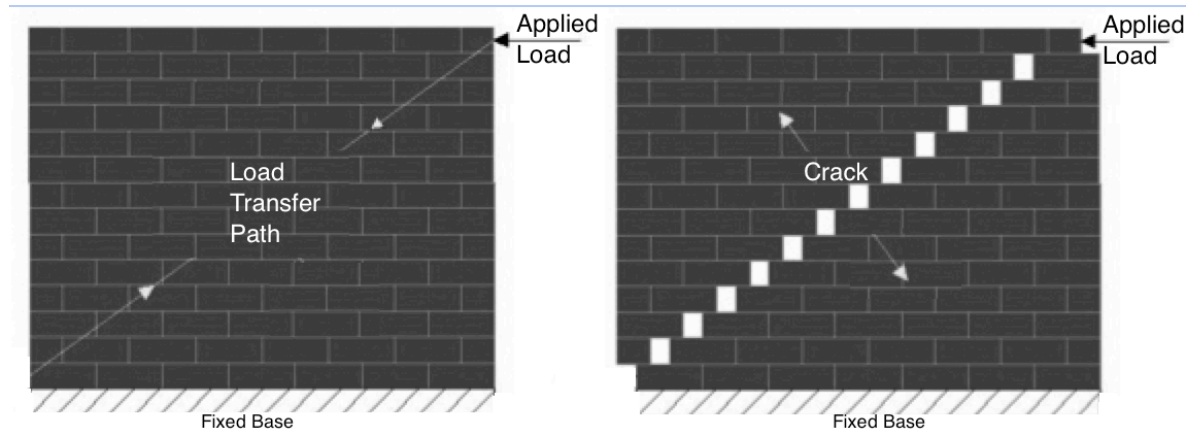
Figure 2.14: Diagonal shear crack in wall follow load transfer path

Shear cracks appear as a result of the opposite lateral forces acting at the top and bottom of the wall. This is the most common mode of failure and it follows the path of load transfer from roof to the foundation i.e. a diagonal crack appears through the wall (Figure 2.14). Usually occurs in wall loaded with considerable vertical as well as horizontal loads and with an aspect ratio of (1:1) to (2:1) in case of bigger vertical loads [51].

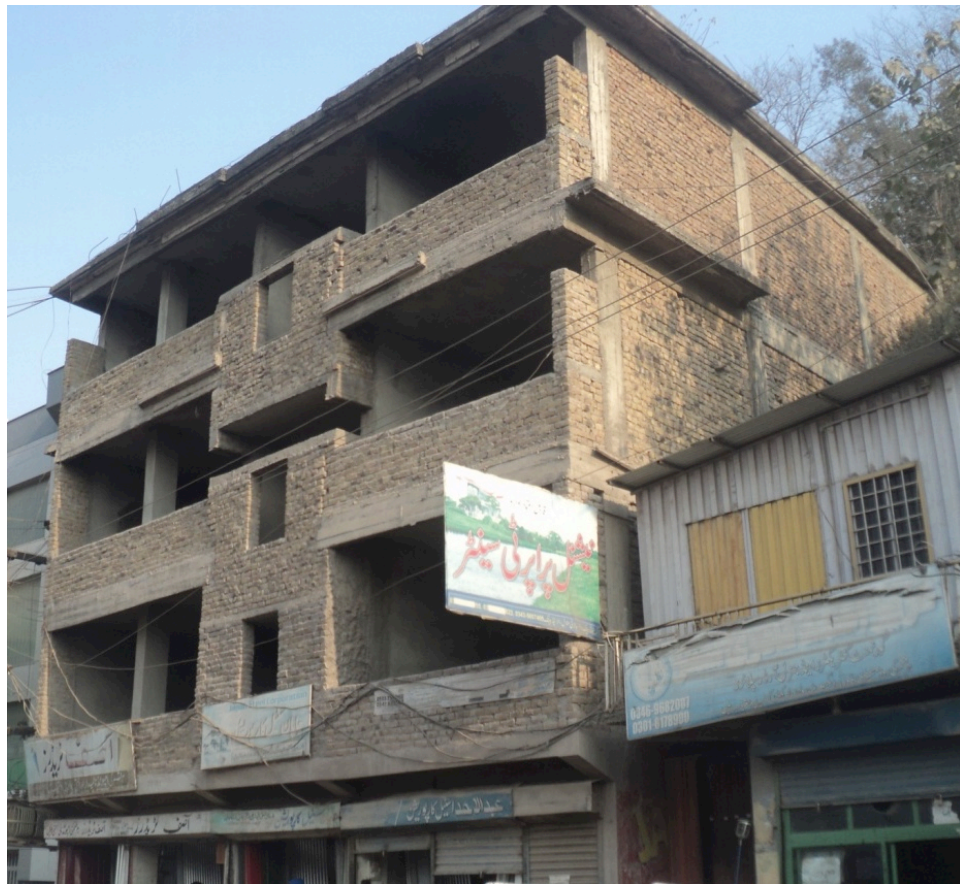
Figure 3.2: Structure with large openings in one direction and discontinuous RCC horizontal member

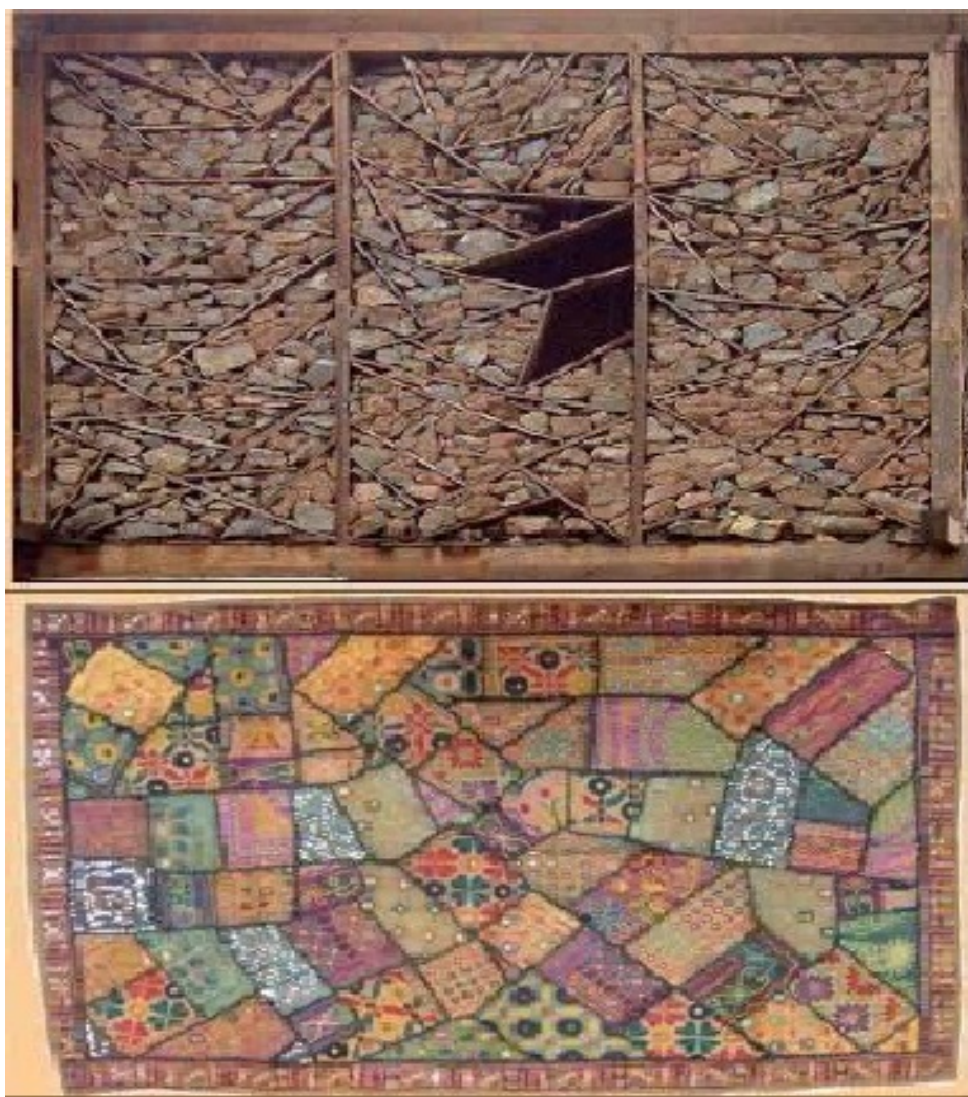
Figure 3.7: Dhajji Wall (Top), Patchwork quilt, 'Dhajji' in Persian [99]

cash incentives were announced to those who implement seismic provisions in their construction. These provisions included the use of reinforced masonry technique in which maximum room size was restricted to 4.5 m (15 feet). Every corner should have 16 mm (5/8 inch) vertical bar starting from the foundation along with stitches made of steel or concrete in L and T shape spaced at 450 mm (1.5 feet) along the height of the wall. Reinforced concrete band of 100 mm (4 inches) with two steel bars of 12.5 mm (½ inch) diameter were suggested at plinth level. All edges of window and opening should have a vertical bar from plinth level to roof level. Soon after these vertical bars were suggested at every 1.2 m (4 feet) distance along the span of the wall. Sill, lintel and roof levels of the wall were to be reinforced with a continuous RCC band of 75 mm (3 inches) [98]. These provisions were similar for block, brick and stone masonry construction. Authorities claim this technique to be implemented in rural areas but not in the city because of the shift to concrete frame structures.

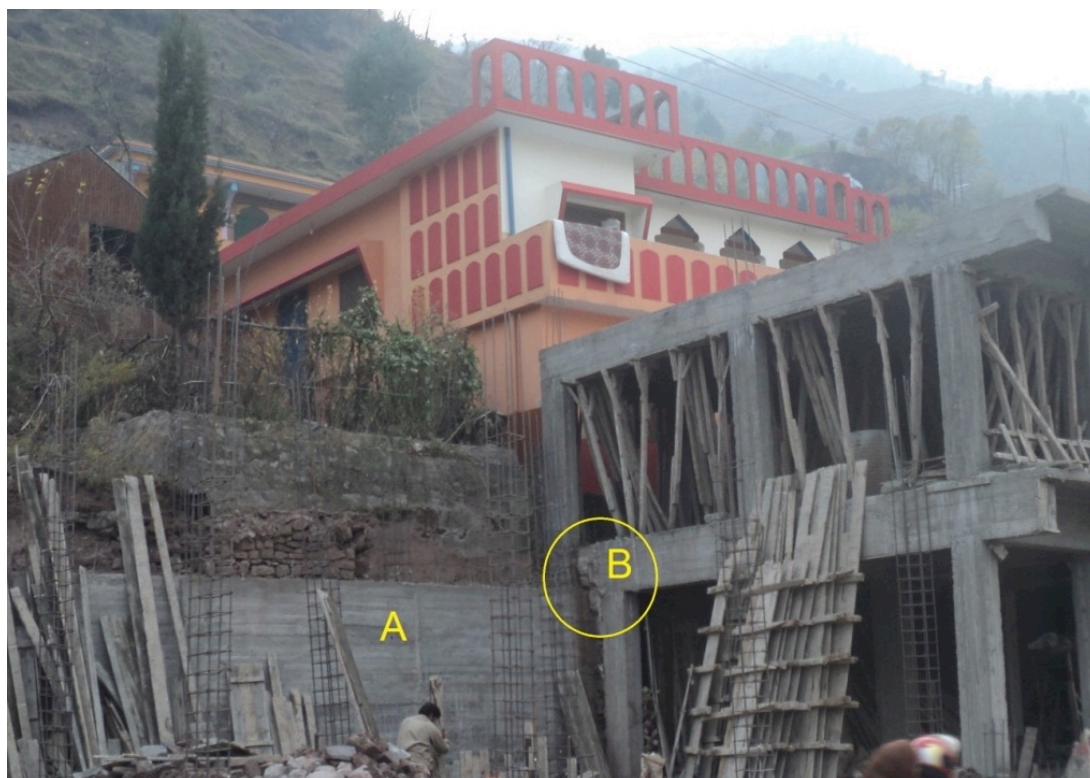
Figure 3.8: Back wall against hill slope constructed of RCC

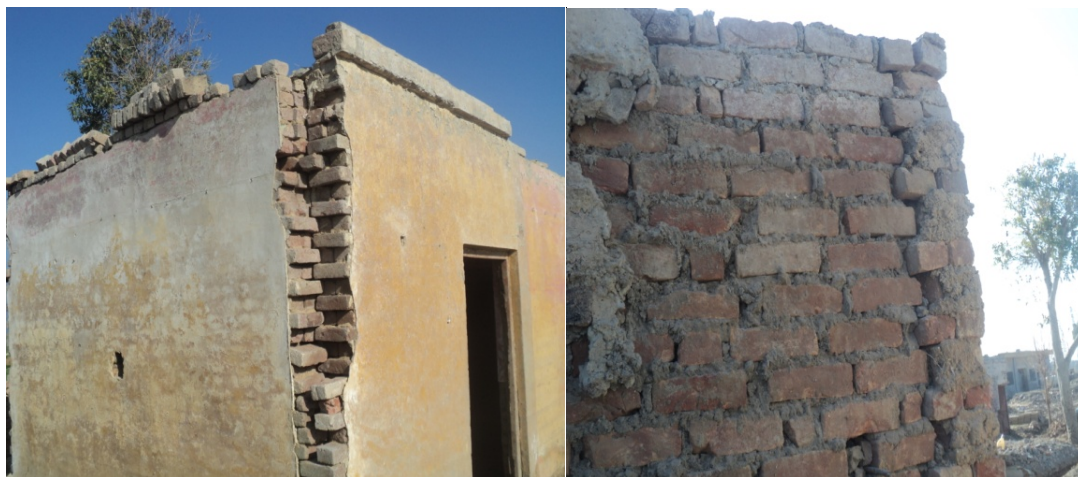
Figure 3.15: Poor Corner joints

Another significant feature for seismic resistant masonry is the joints between two walls such as the corners of structure. Mirpur construction is negligent of the implications of proper wall joints during an earthquake (Figure 3.15).

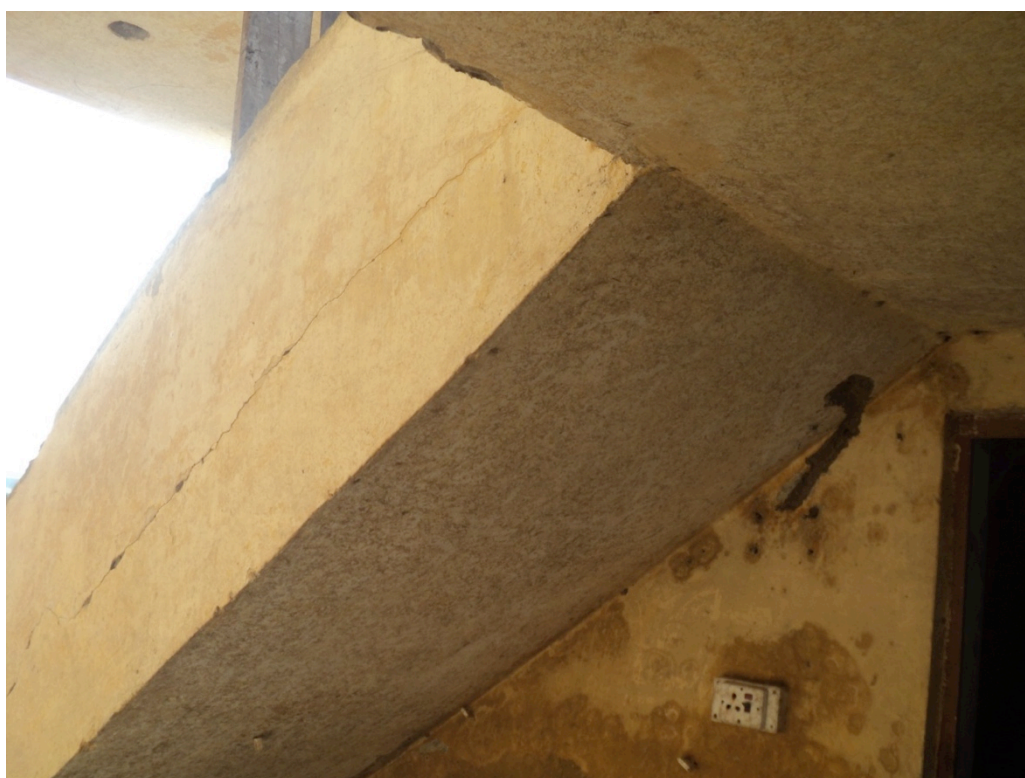
Figure 3.16: Stairs resting on the wall of structure

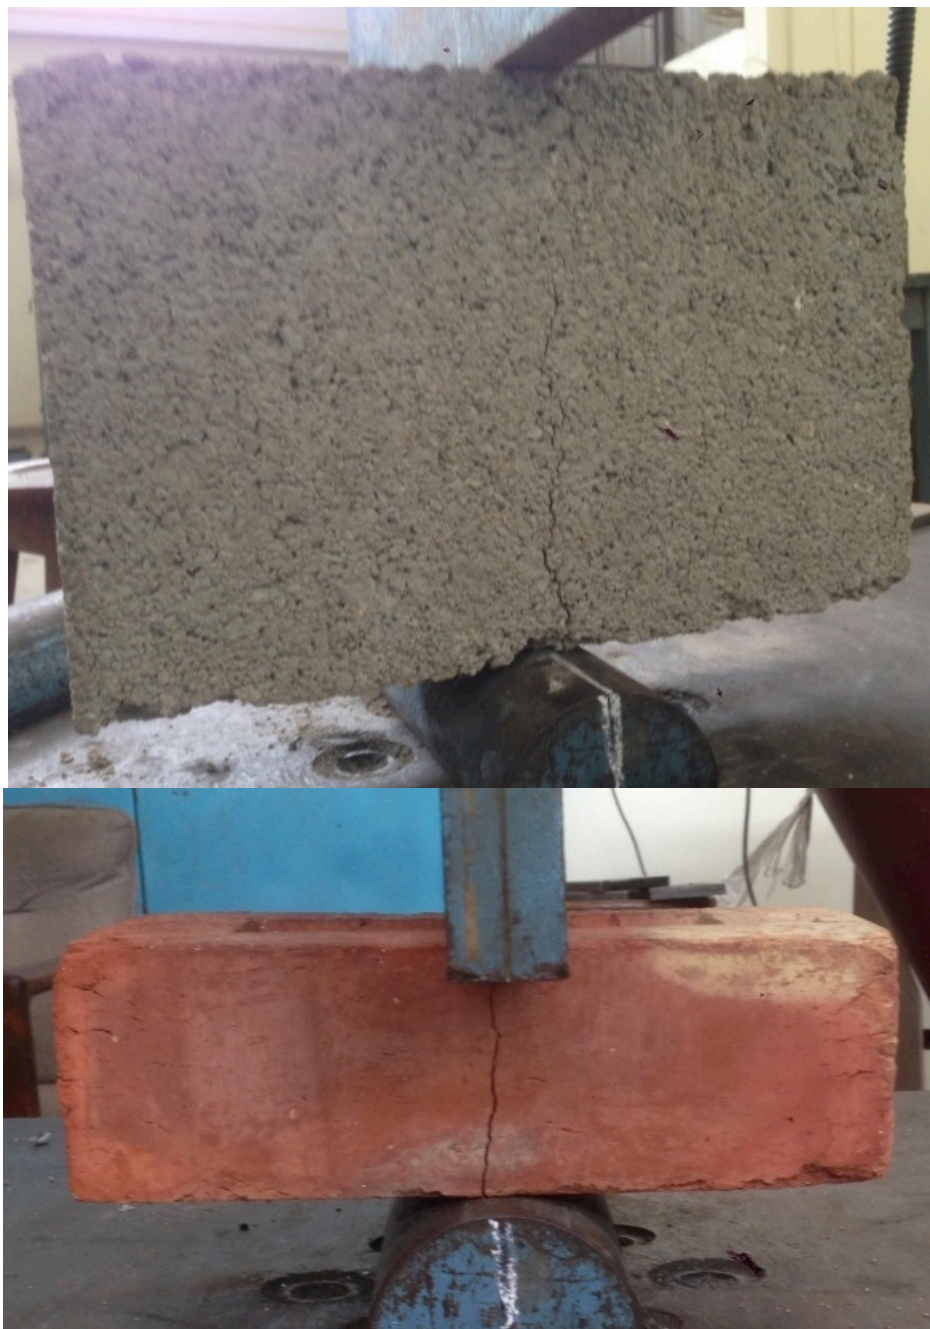
Figure 5.10: Tensile splitting test for concrete block (*top*); red brick (*bottom*)

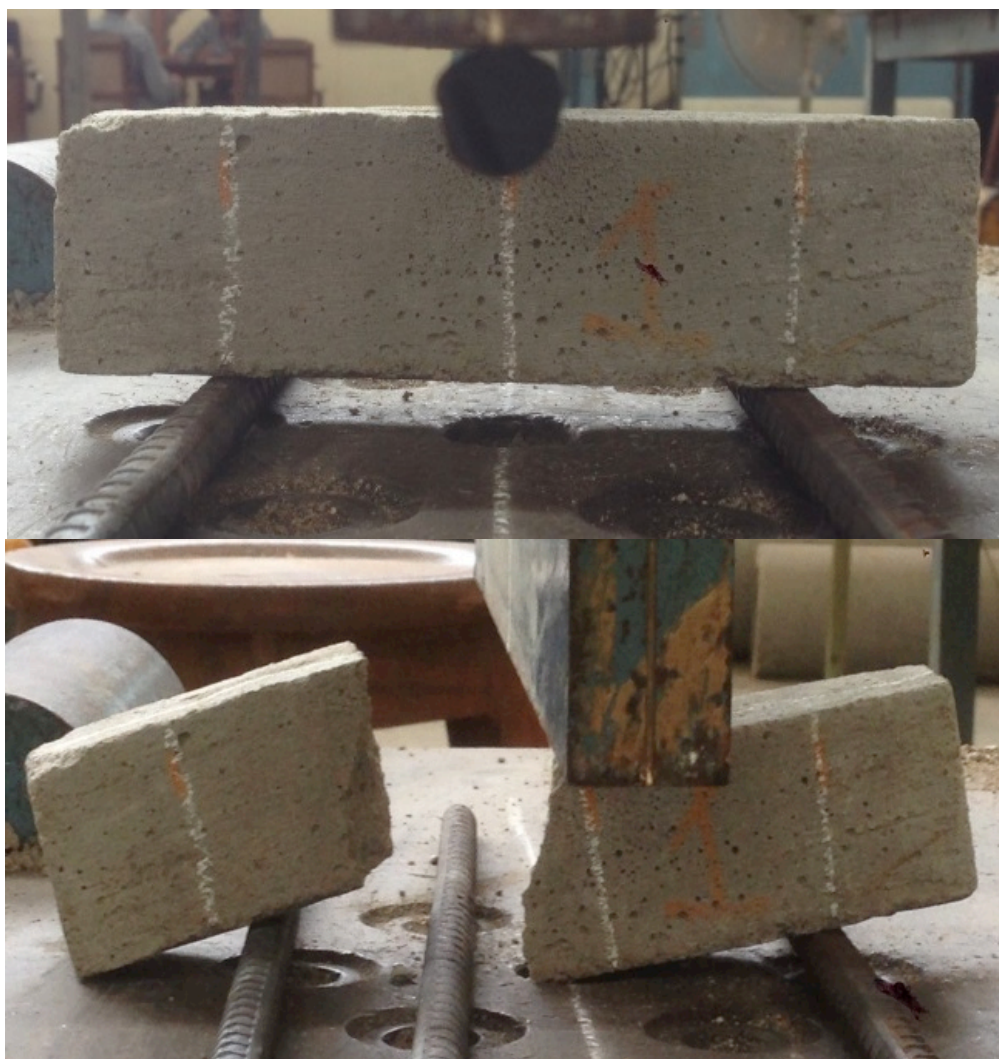
Figure 5.11: 3-Point bending test for mortar

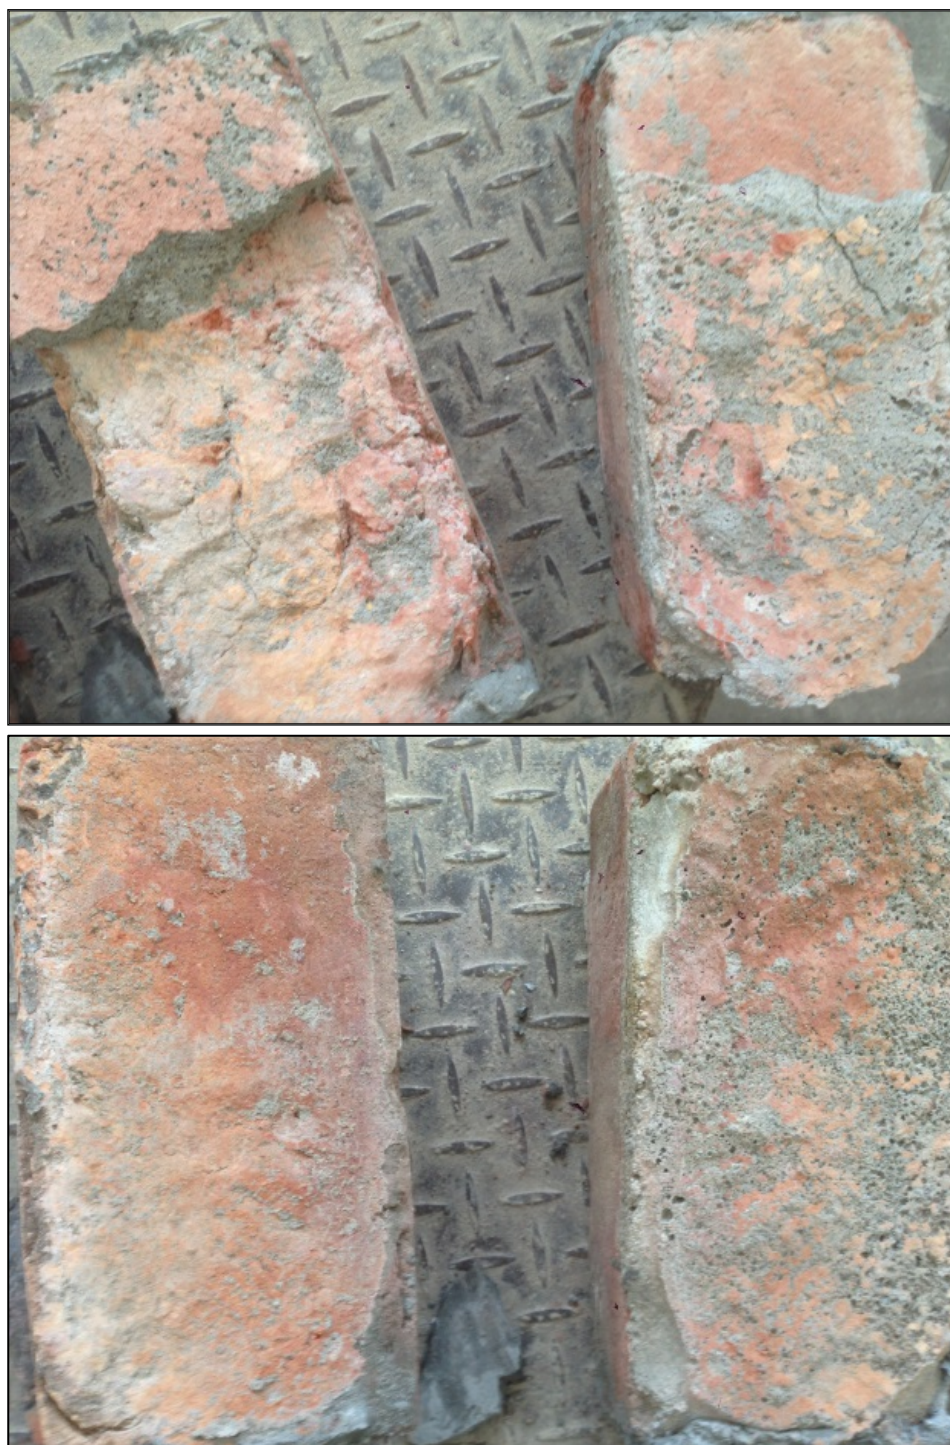
Figure 5.15: R2M1 samples after Initial shear strength test

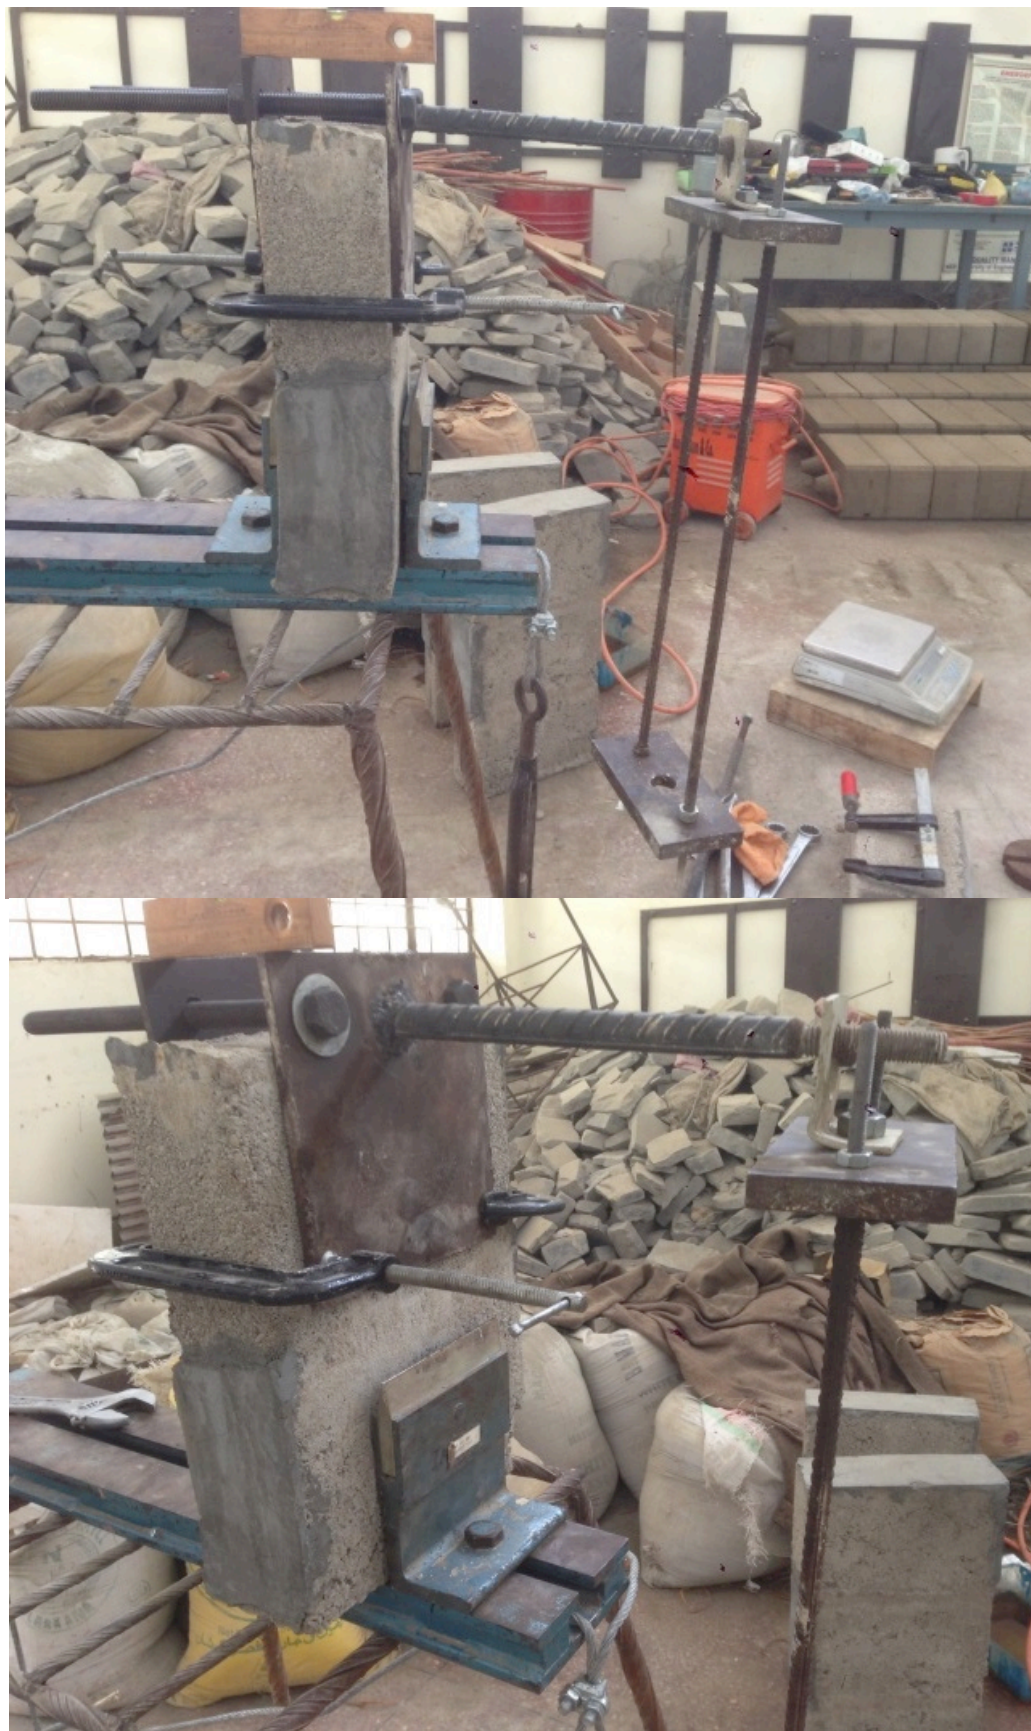
Figure 5.16: Bond Wrench test setup

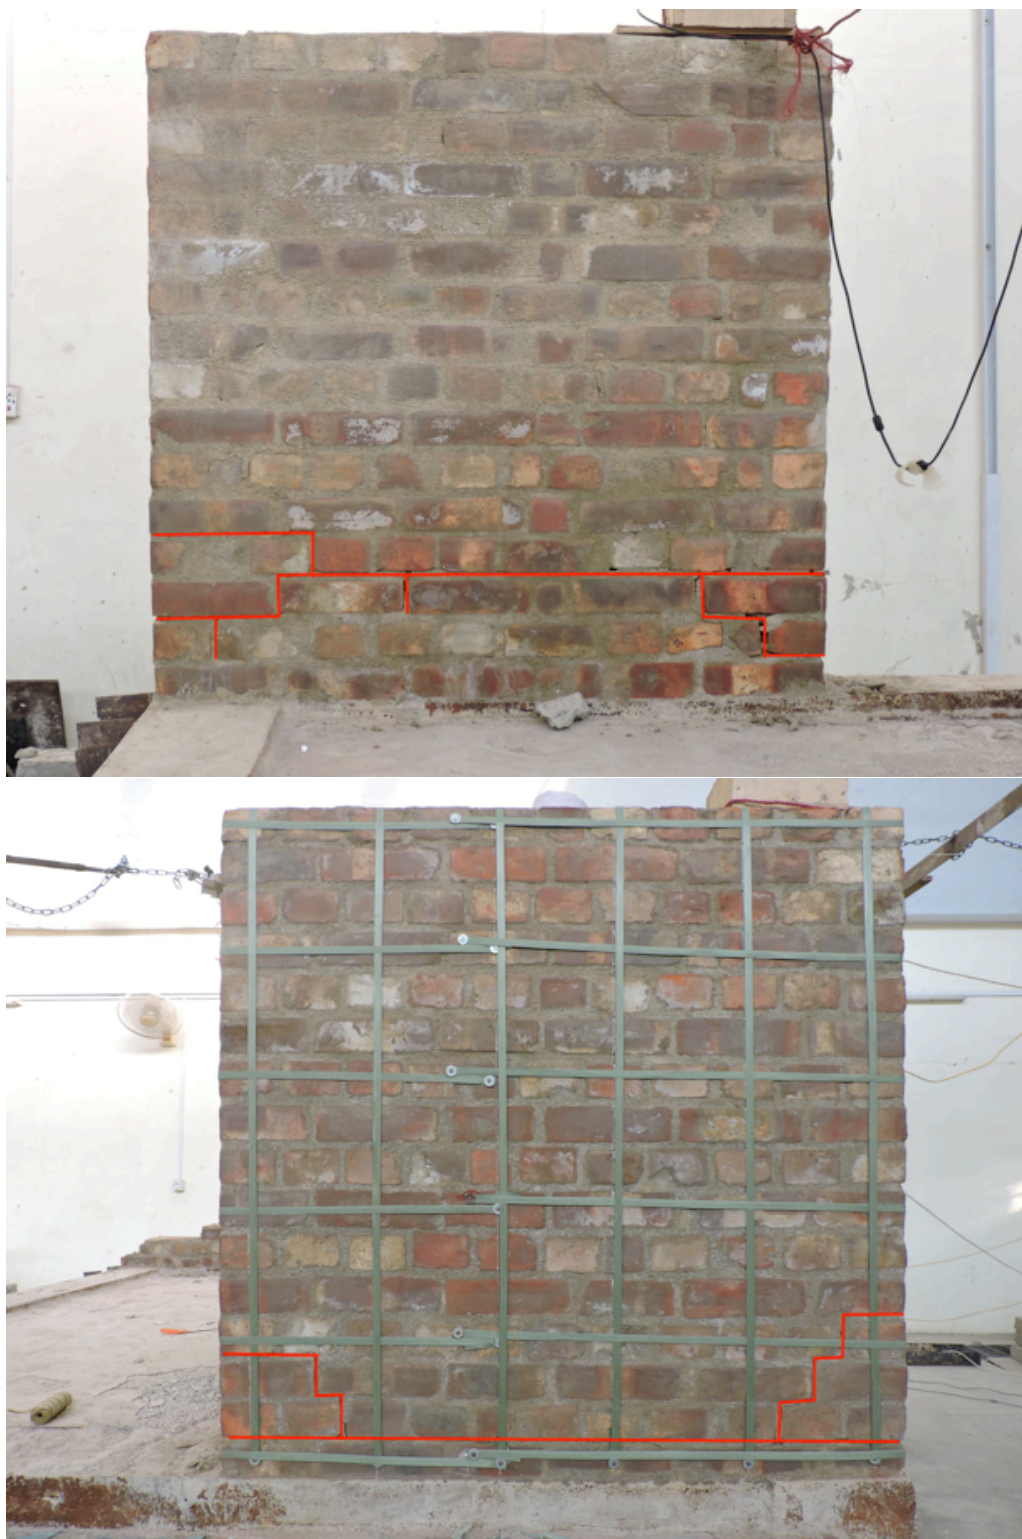
Figure 6.7: Non-retrofit (*top*) and retrofit (*bottom*) specimen at cracking (Grade-3)

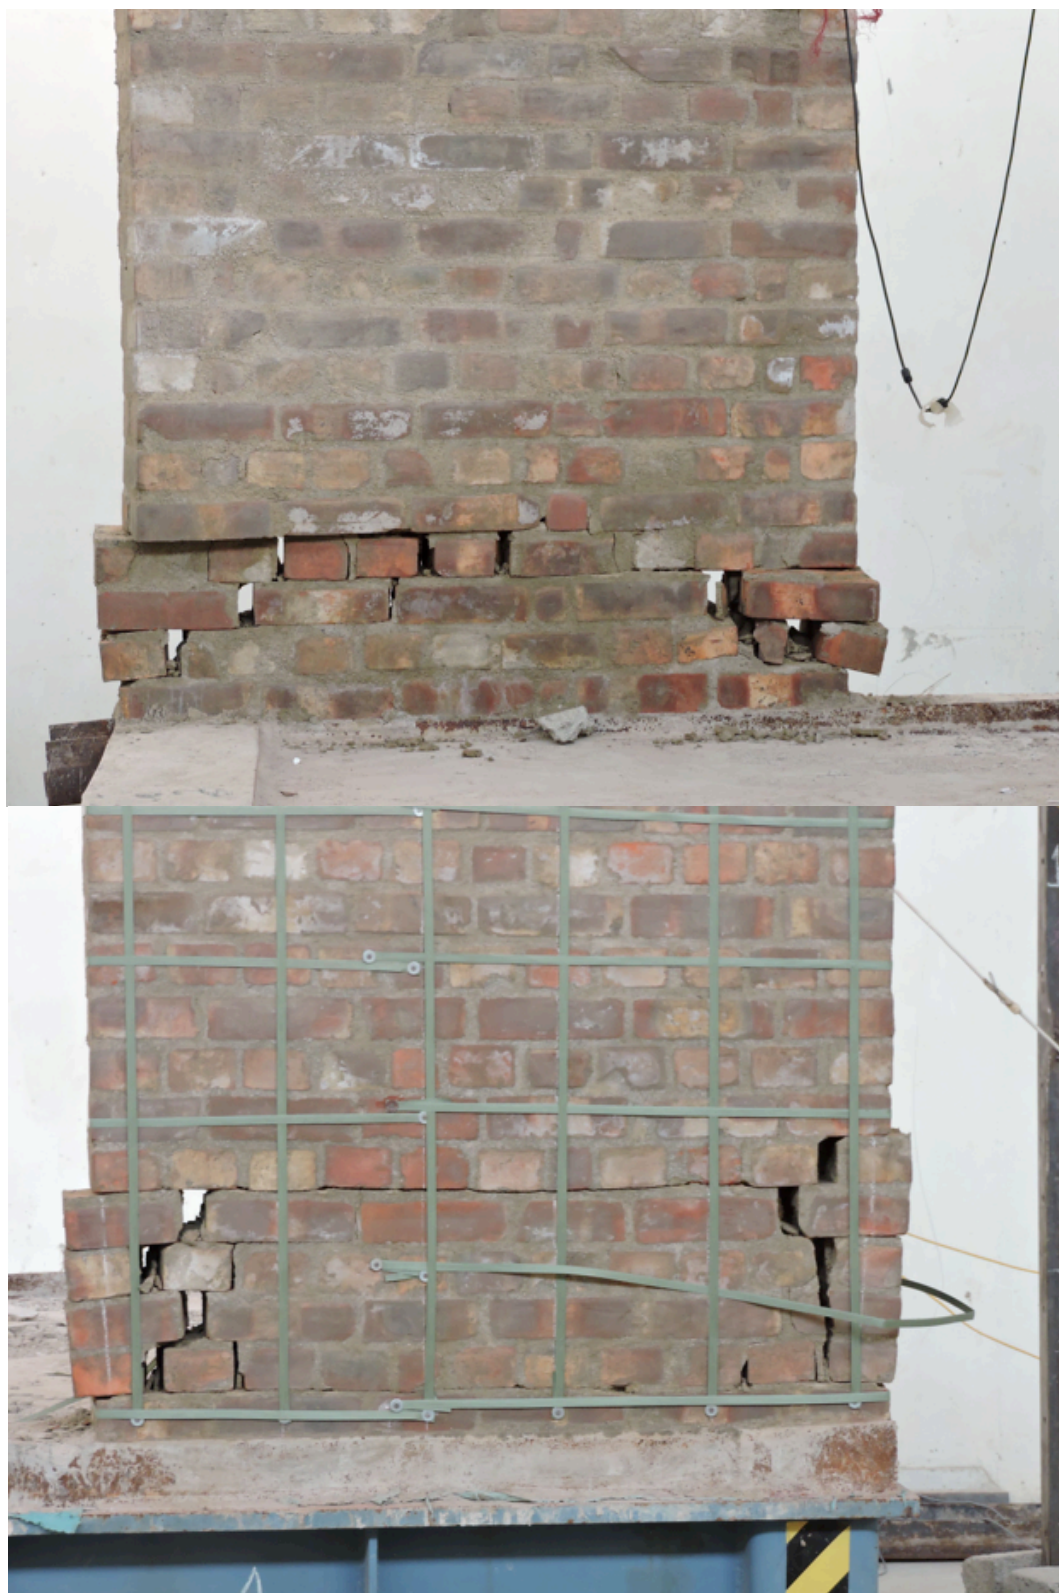
Figure 6.8: Non-retrofit (*top*) and retrofit (*bottom*) specimen before collapse (Grade-4)

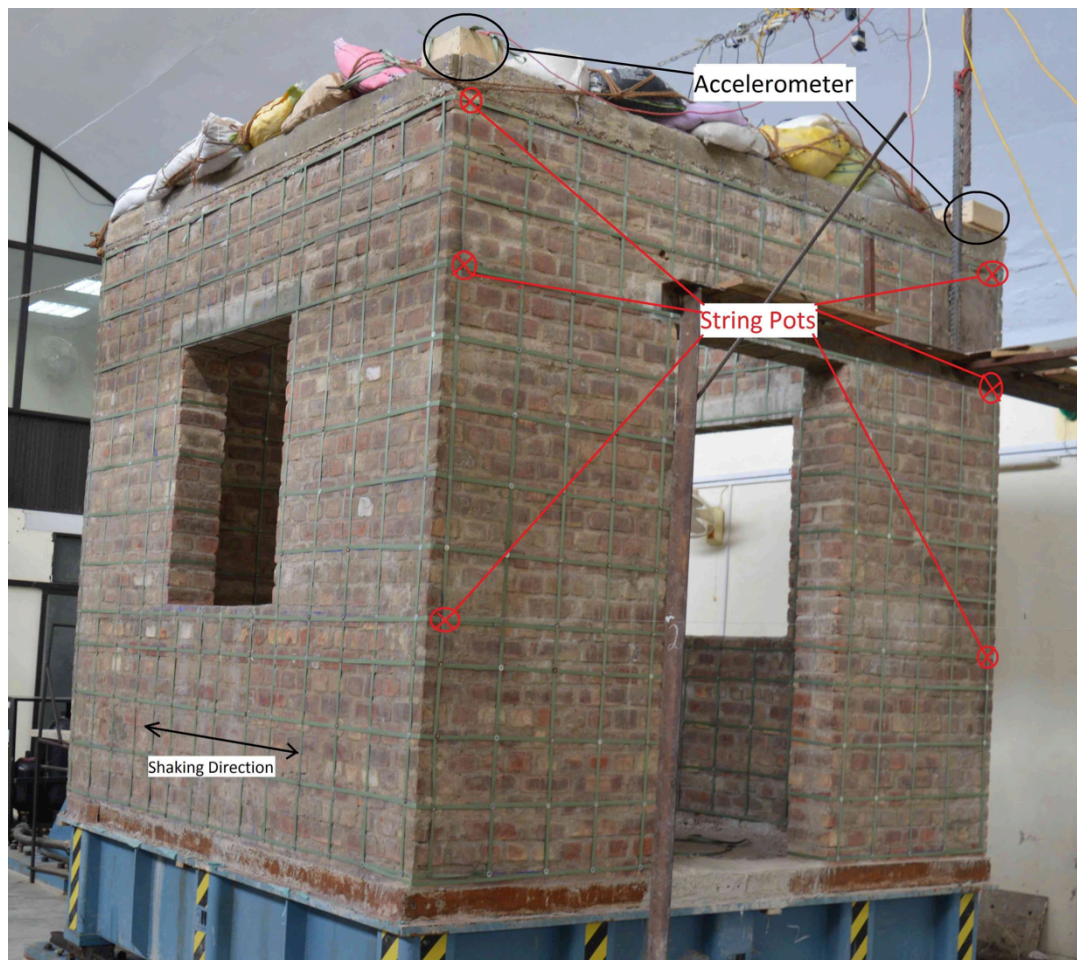
Figure 7.5: Instrumentation for Room-1

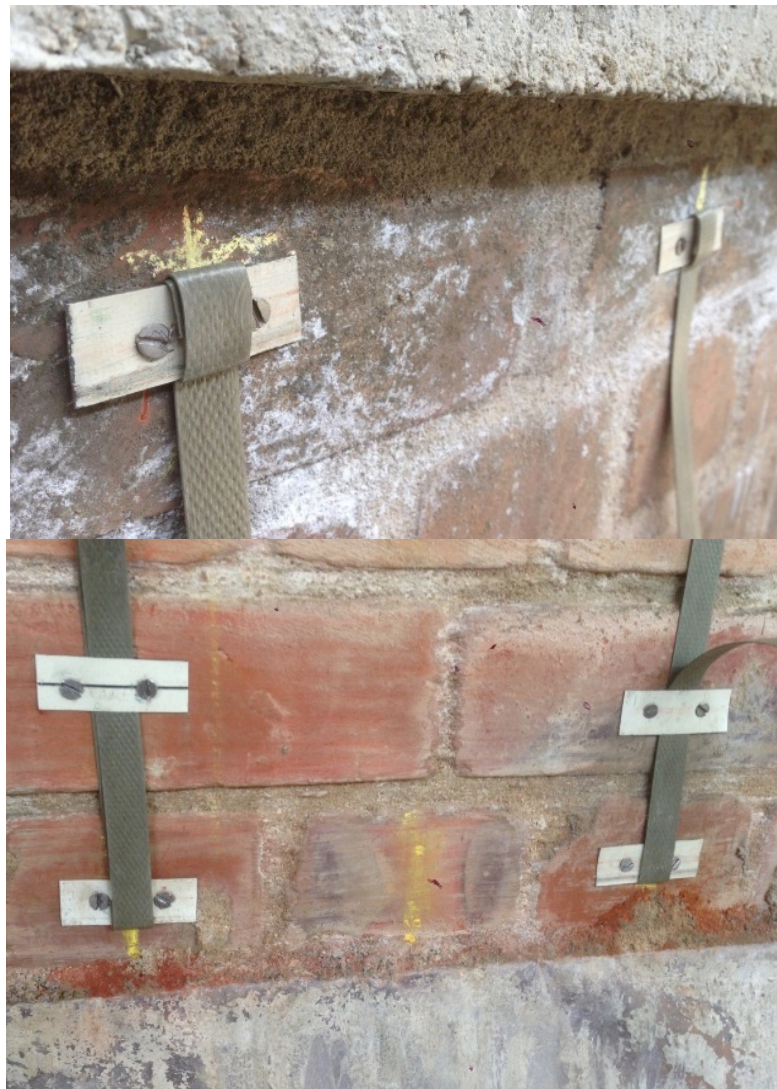
Figure 7.9: First end (*left*), Second end (*right*) revised connection detail for Room-2

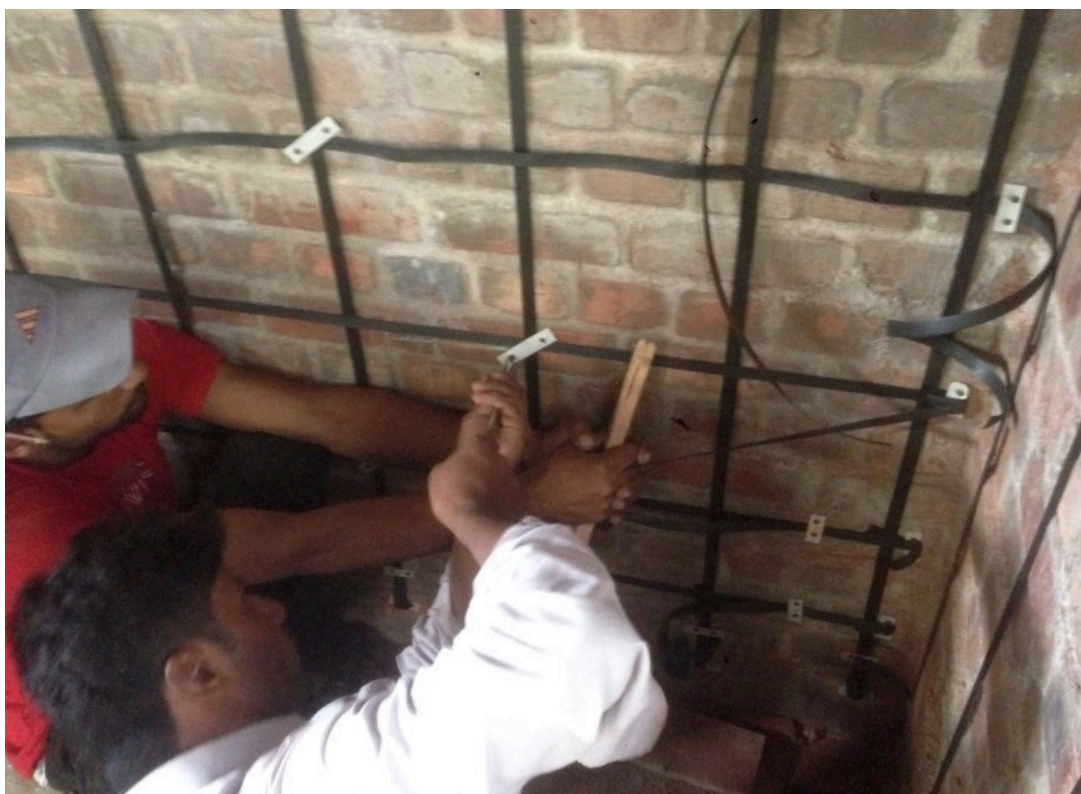
Figure 7.10: Applying tension in PP-bands to remove looseness before fixing Second end

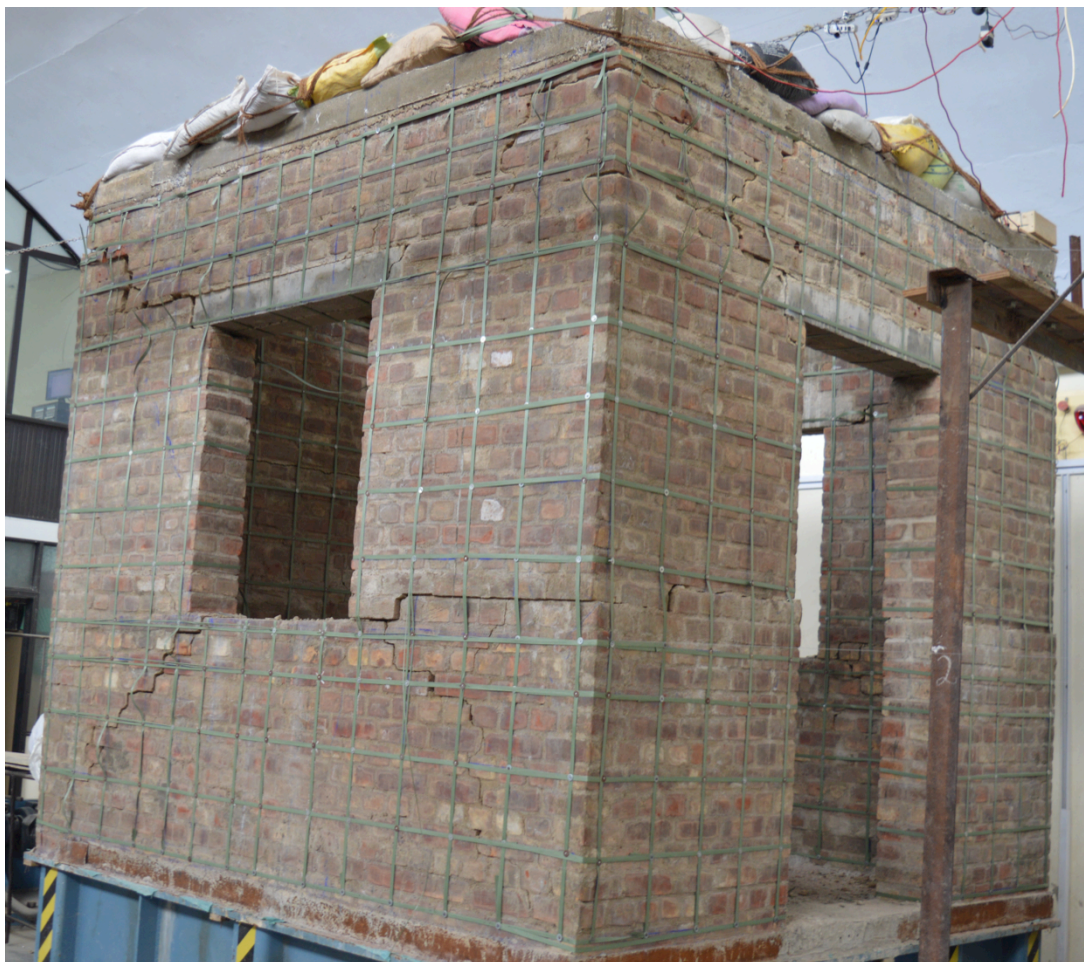
Figure 7.13: Cracks in Room-1 after the initiation of Grade-3 damage in wave-2

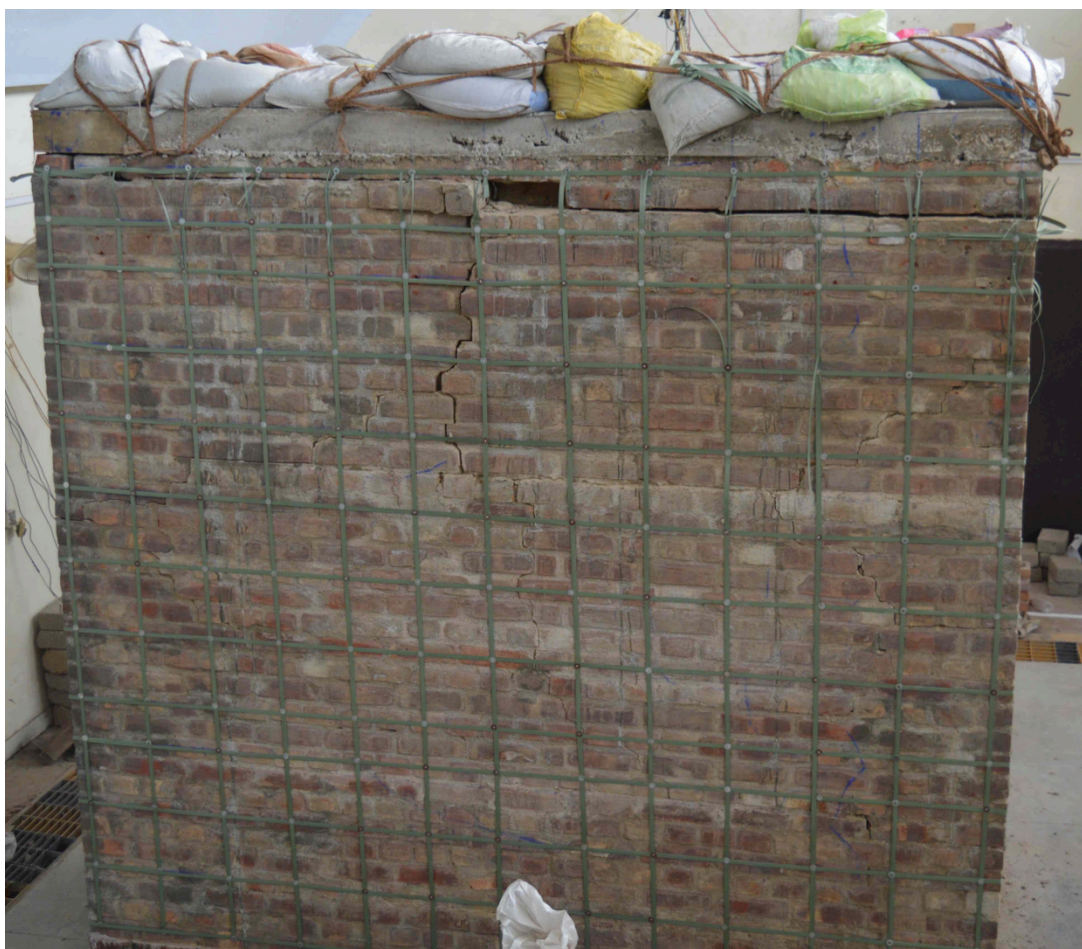
Figure 7.14: Cracks in solid wall of Room-2 at initiation of grade-3 damage

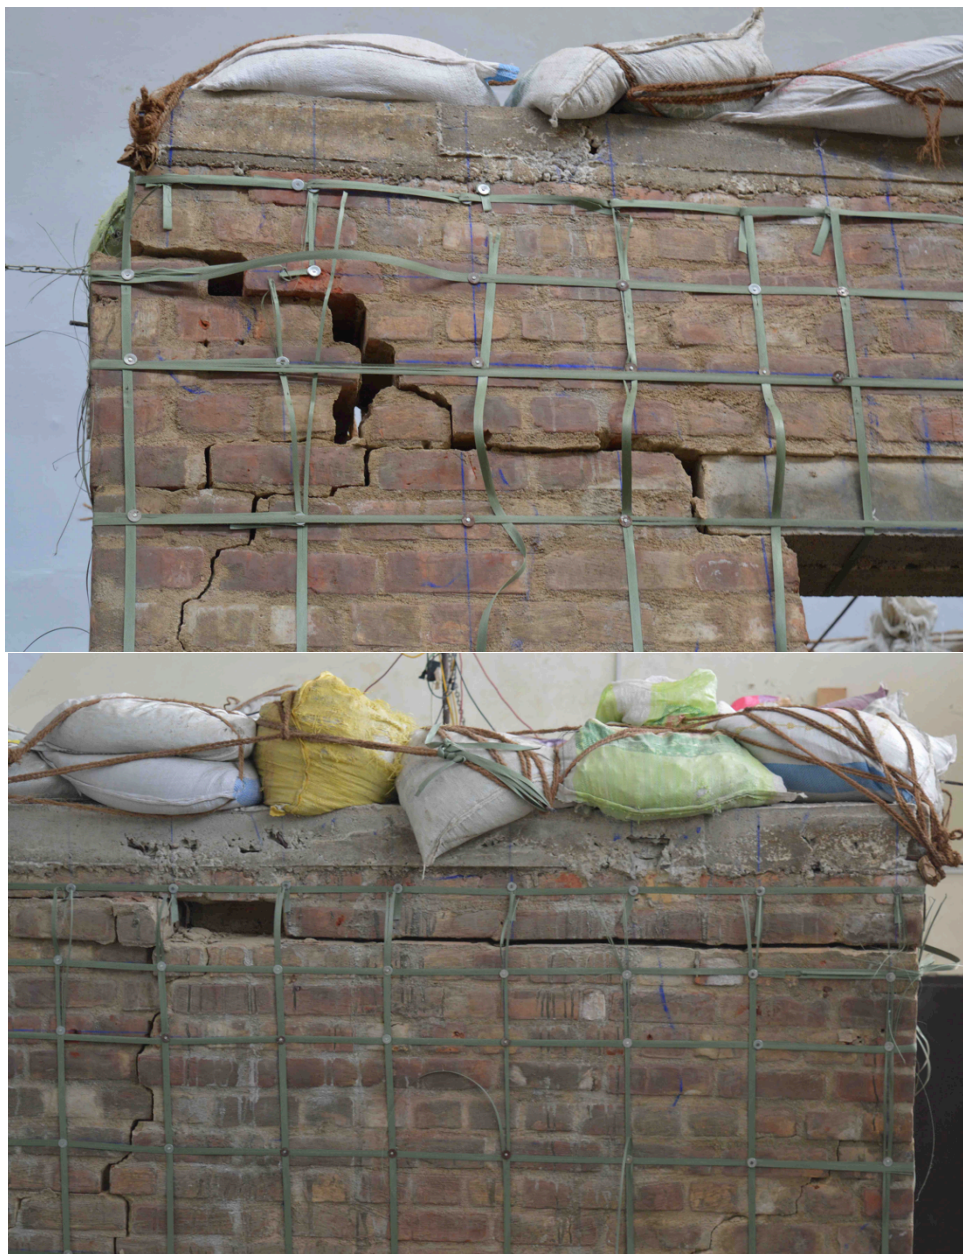
Figure 7.15: Rupture of PP-bands due to the selected connection technique
